**NEW JERSEY TURNPIKE AUTHORITY
GARDEN STATE PARKWAY
NEW JERSEY TURNPIKE**

**BRIDGE INSPECTION
PROGRAM**

**MANUAL FOR SIGN
STRUCTURE
INSPECTION**

**VERSION 1.3
MARCH 2025**

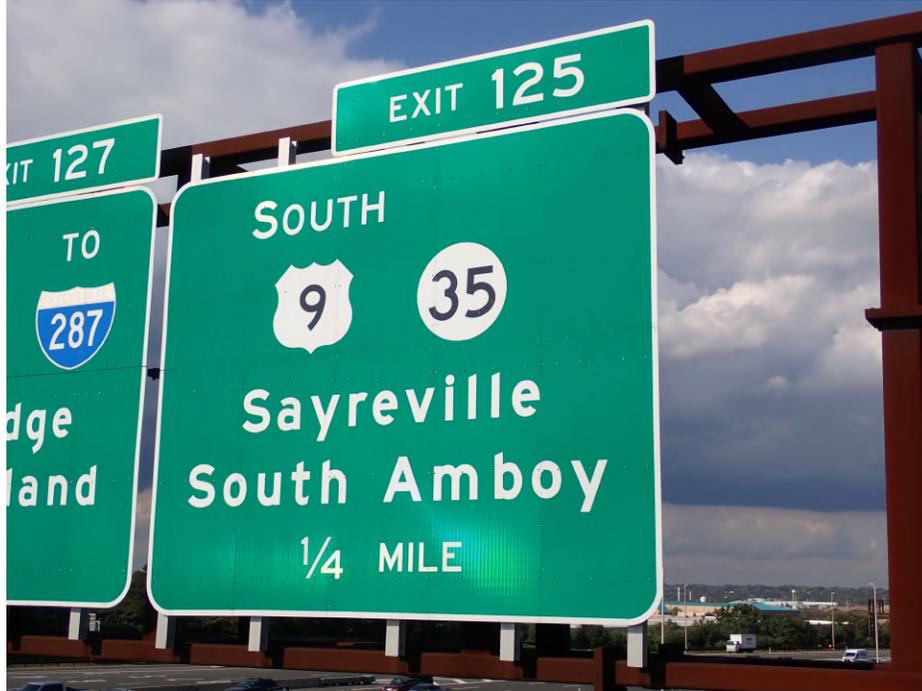
Photograph No. 3

Close up view of the right sign panels, looking northwest. Work Done:
Sign panels have been replaced under Contract No. P300.229.

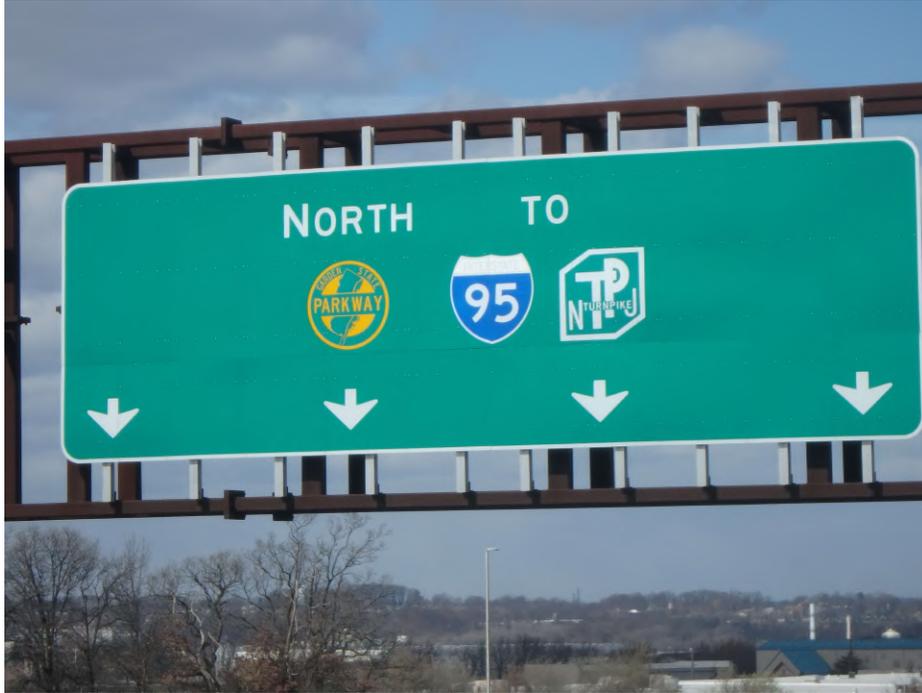
Photograph No. 5

Close up view of the left sign panel, looking north. Work Done: Sign panel has been replaced under Contract No. P300.229.

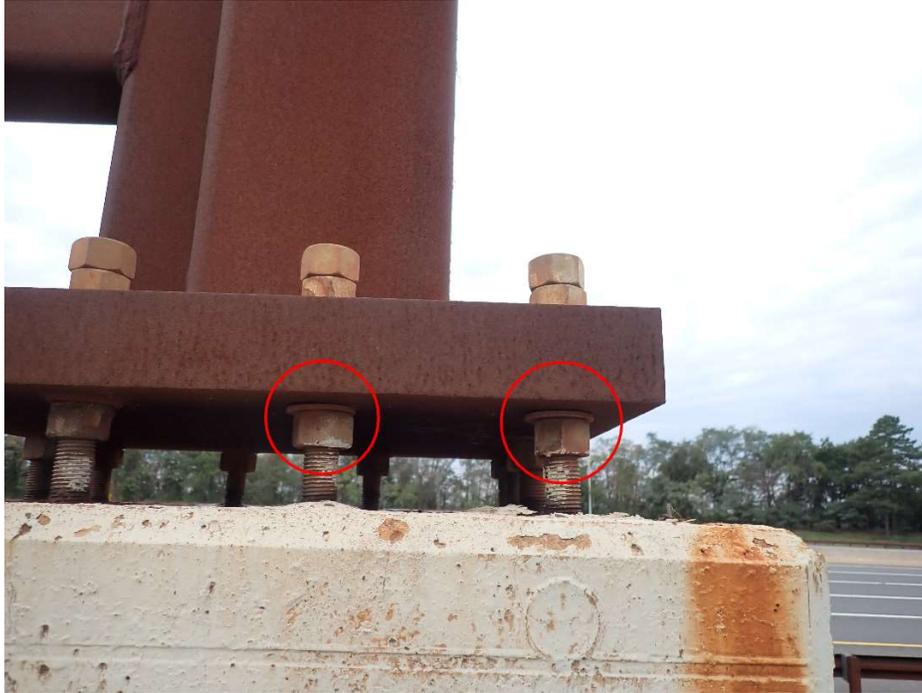
Photograph No. 13

Loose lower washers at anchor bolts 3 and 4 at the north post of the west tower, looking west. Note the minor peeling (10%) of epoxy coating.

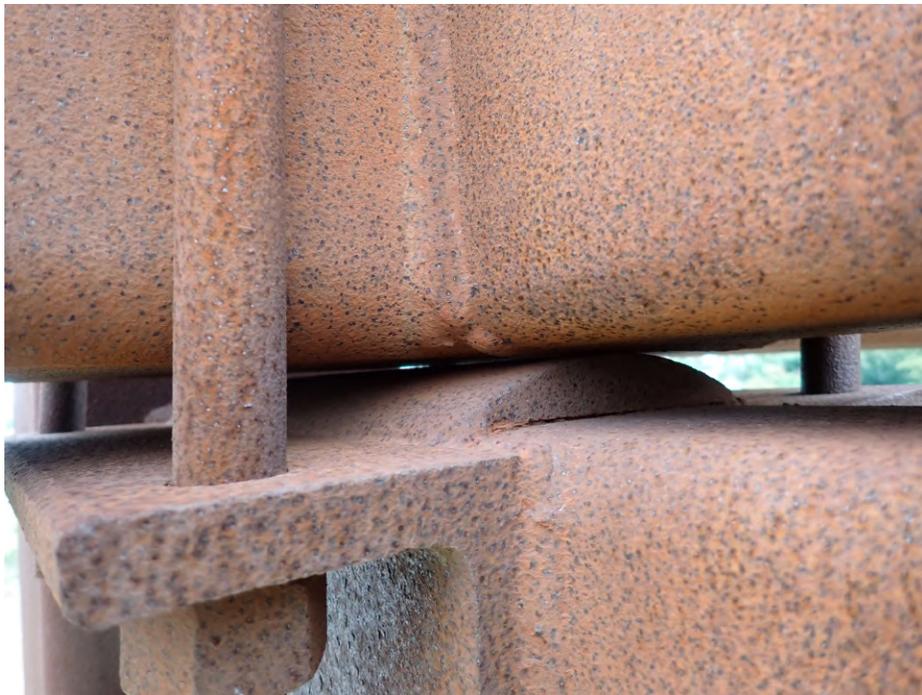
Photograph No. 14

Gap (up to 1/4") at the north edge of the north lower chord at the west tower, looking southeast. Note the chord is bearing at the south edge.

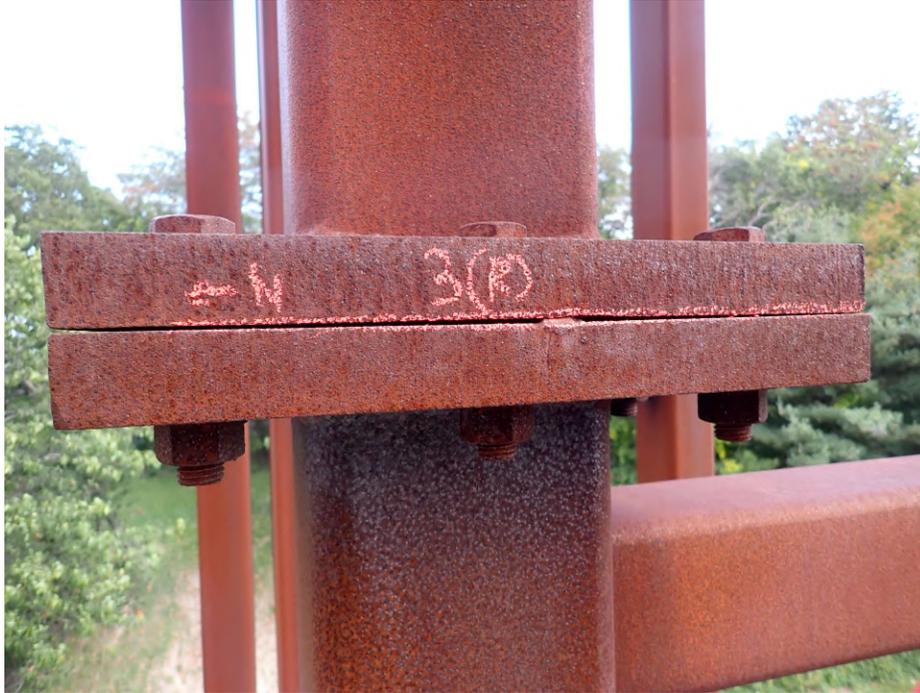
Photograph No. 17

Gap (1/16" to 1/8") between the flange plates at the west face of vertical strut splice 3 from the east at the north plane, looking east. Similar at multiple locations.

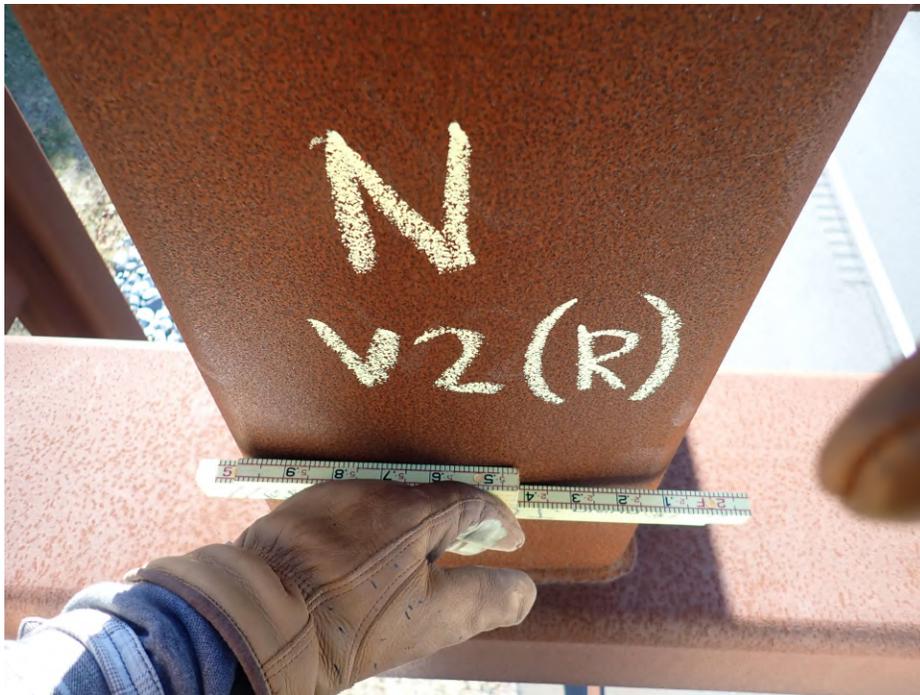
Photograph No. 18

1/2" bulge in the north face of vertical strut 2 from the right at the north truss, looking down and south. Similar at multiple locations.

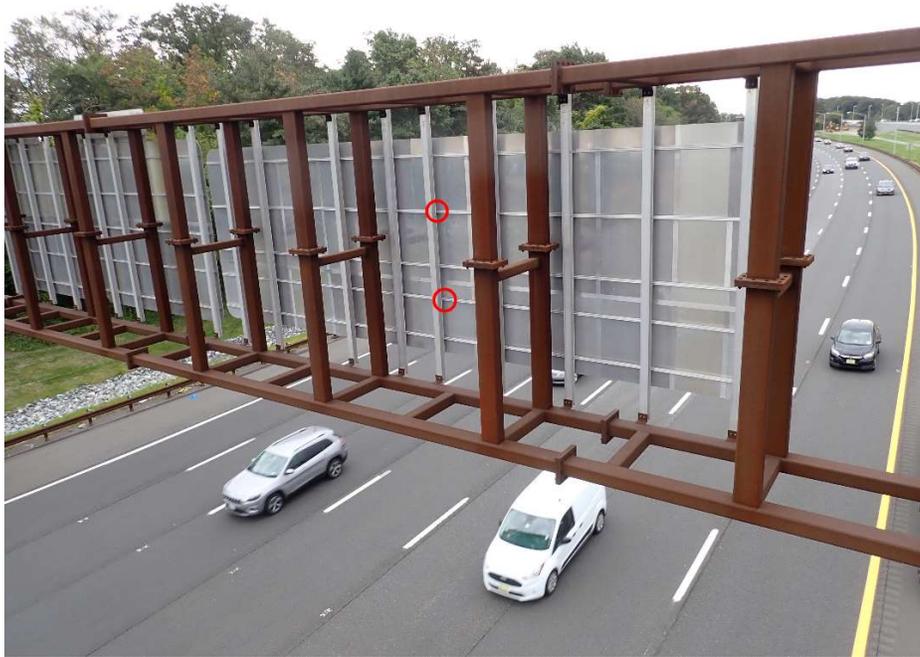
Photograph No. 19

Missing splices (discontinuous) at Stringer 2 and 4 (from the bottom) between Hanger 4 and 5 (from the left) at the left sign panel, looking southeast.

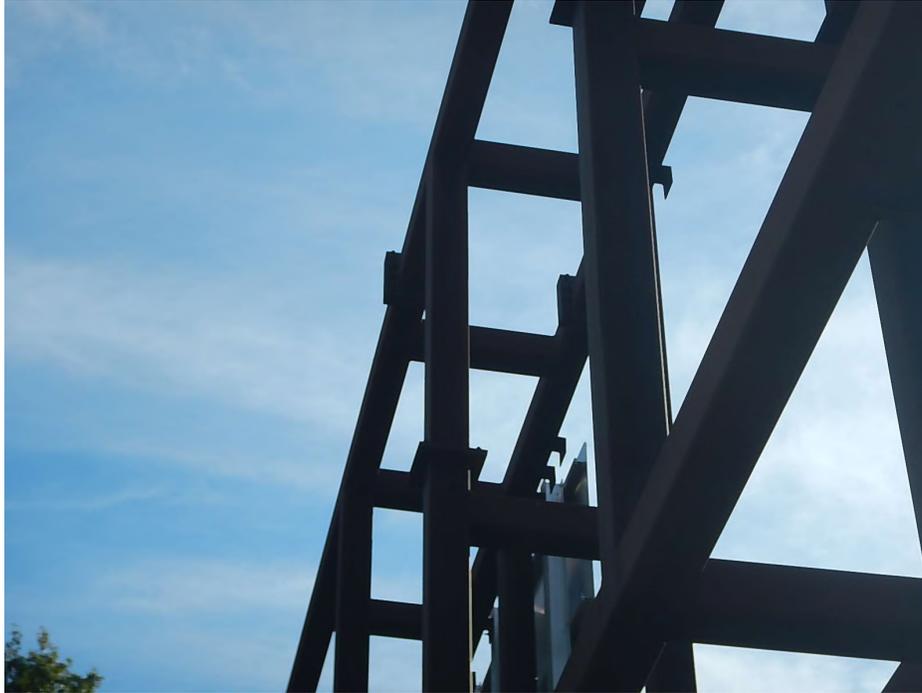
Photograph No. 3

Monitoring Inspection #3, the crack in Vertical 3 of the north truss plane exhibits no visible changes, looking southeast.

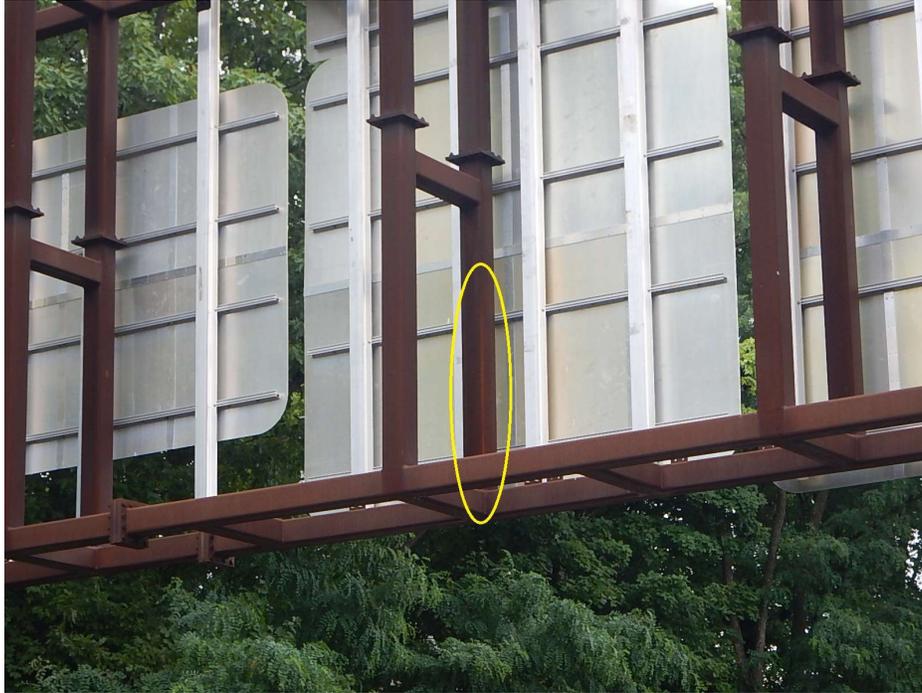
Photograph No. 5

Monitoring Inspection #4, Vertical 7 at the south truss exhibits discoloration / staining, looking southeast.

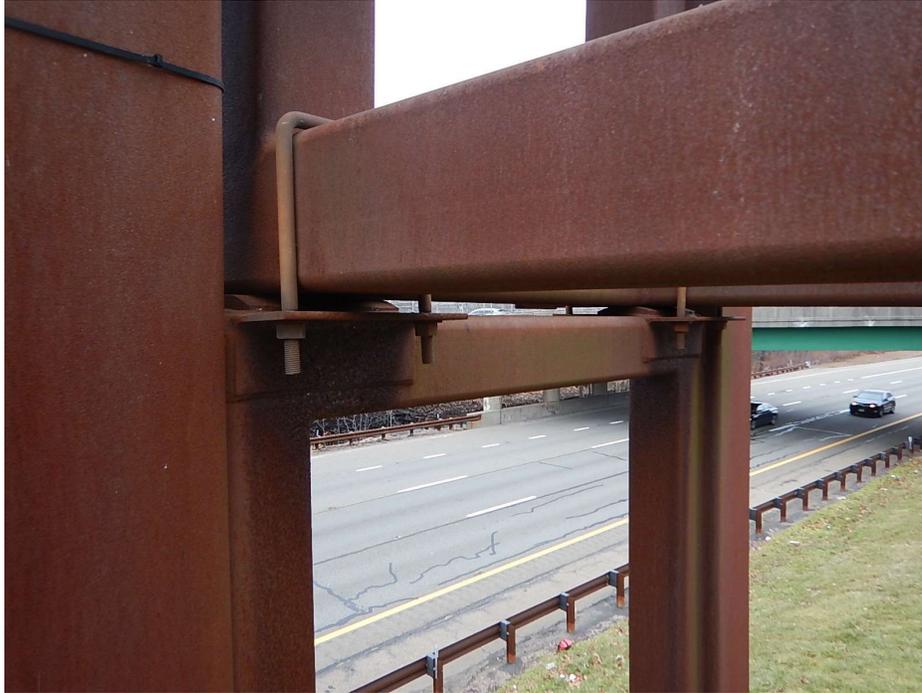
Photograph No. 7

Monitoring Inspection #5, the north and south lower chords are fully bearing at the west end frame, looking northwest.

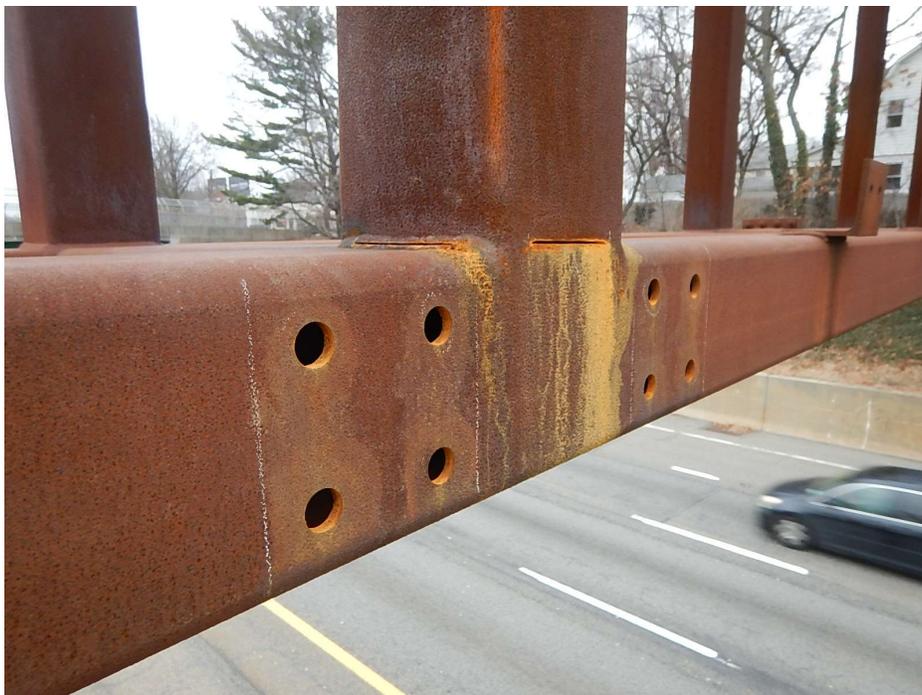
Photograph No. 8

Monitoring Inspection #5, repairs to the cracked member is underway by P100.562, looking northeast.

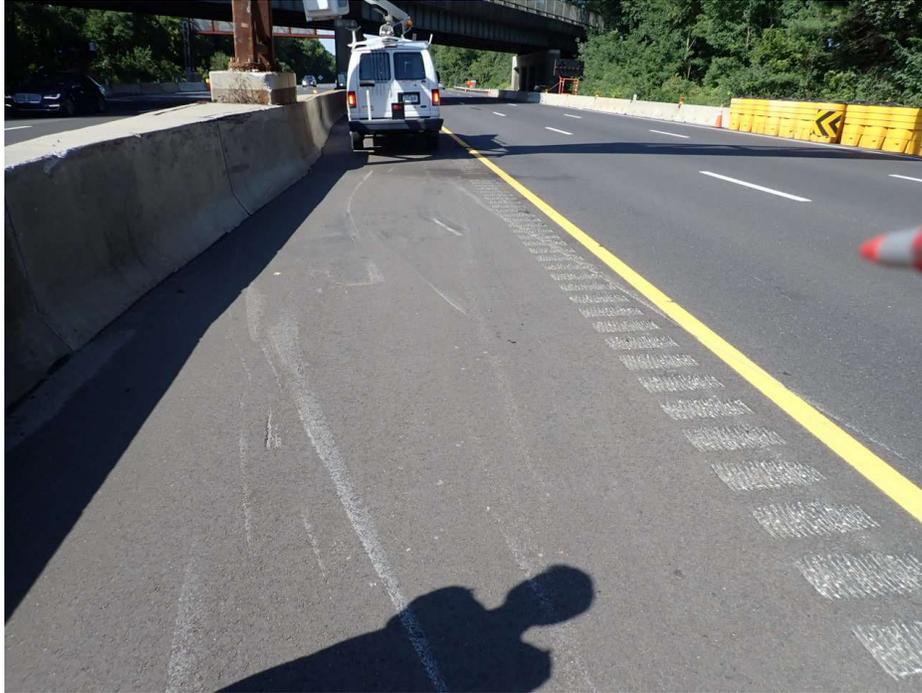
Photograph No. 3

The pavement in the NS Roadway exhibits gouges (80' L x up to 1/8" D) in the left shoulder starting 80' north of the sign, looking south.

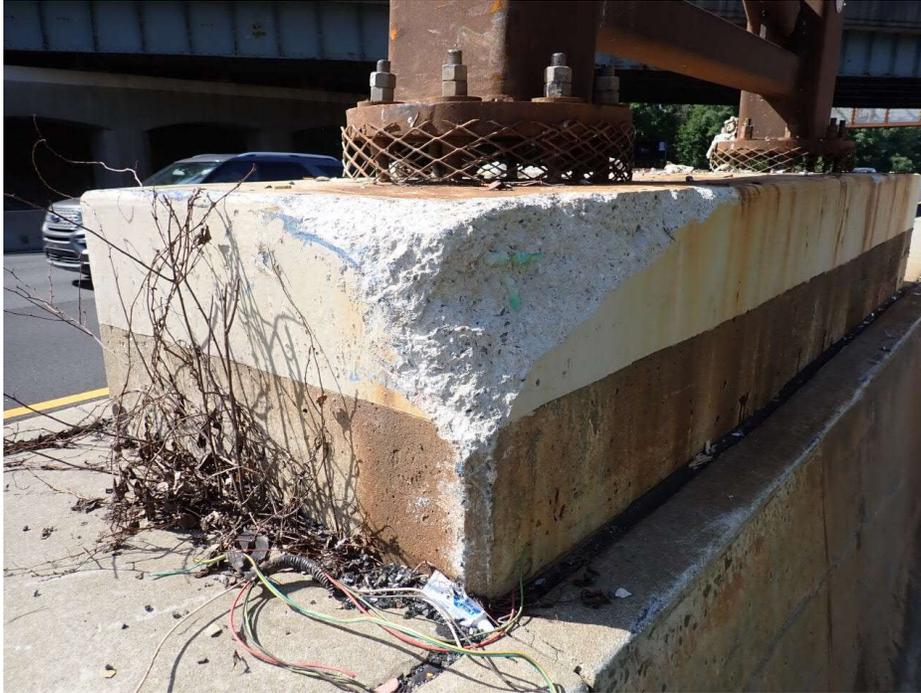
Photograph No. 5

The east foundation exhibits a spall with exposed rebar (14" W x 29" L x 12" H x up to 3" D) at the northwest corner, looking southeast.

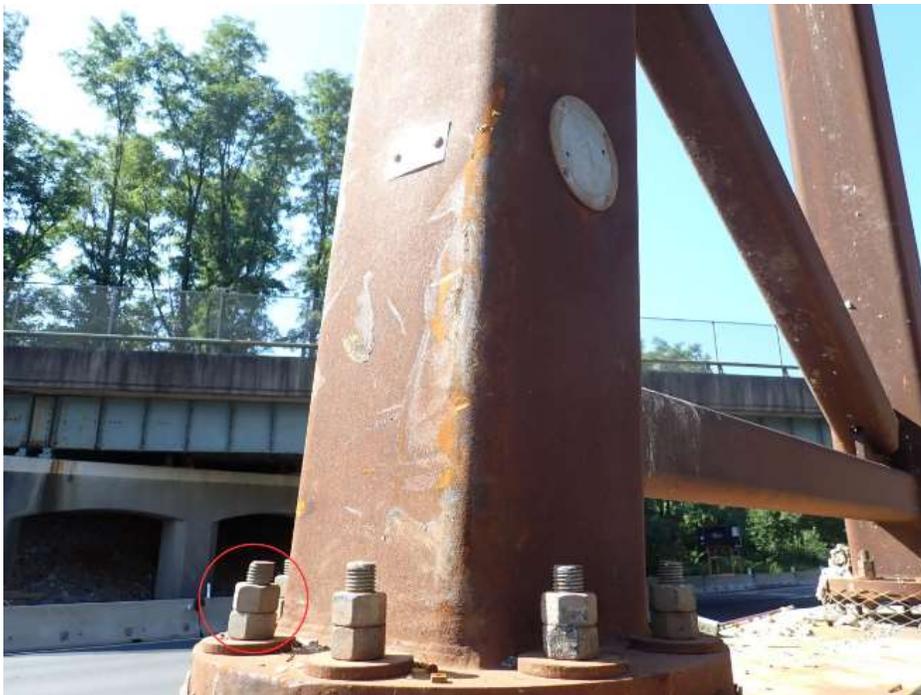
Photograph No. 6

Anchor bolt No. 1 at the east foundation is tilted to the southwest (1/8" over 2" H), looking down and south., looking southeast.

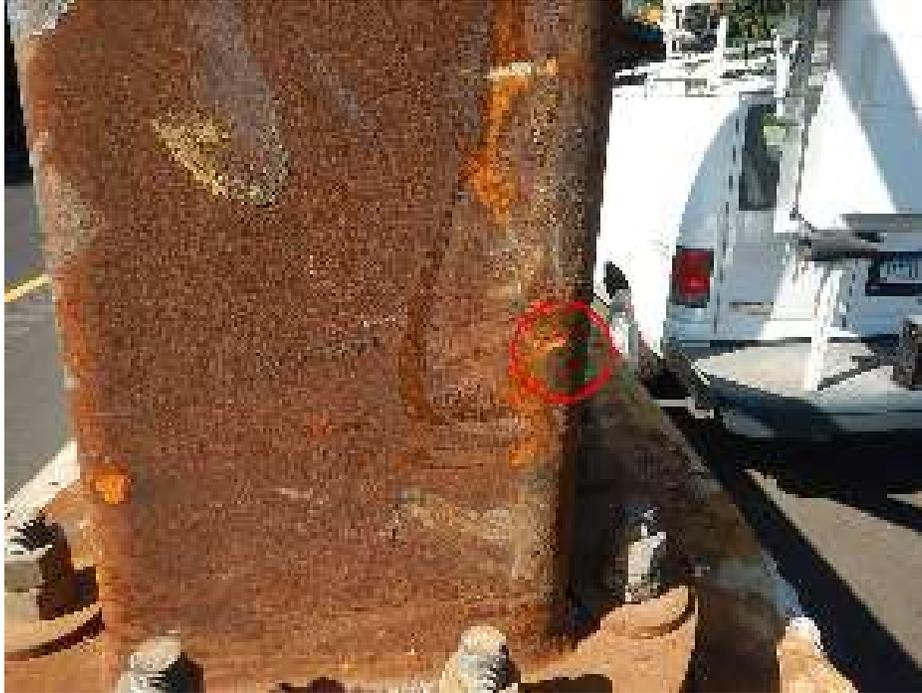
Photograph No. 7

The north column of the east end frame exhibits a gouge (5/8" L x 3/8" H x up to 1/16" D) at the northwest corner located 8-7/8" above the baseplate, looking south. Note the scrape marks on the column.

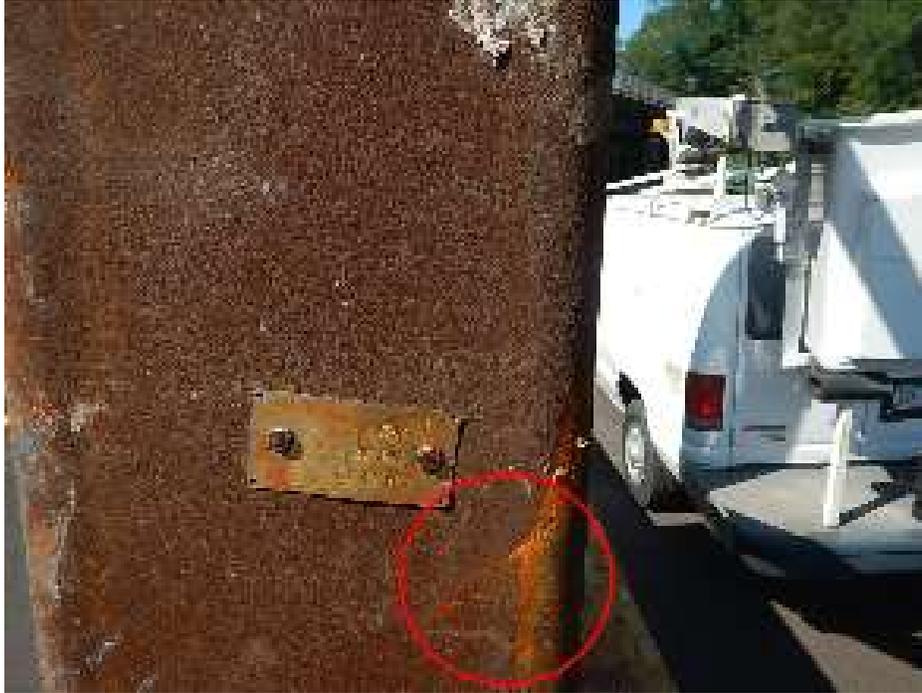
Photograph No. 9

The north column of the east end frame exhibits a gouge (3/4" L x 1/8" H x less than 1/16" D) at the northeast corner located 20" above the baseplate, looking south.

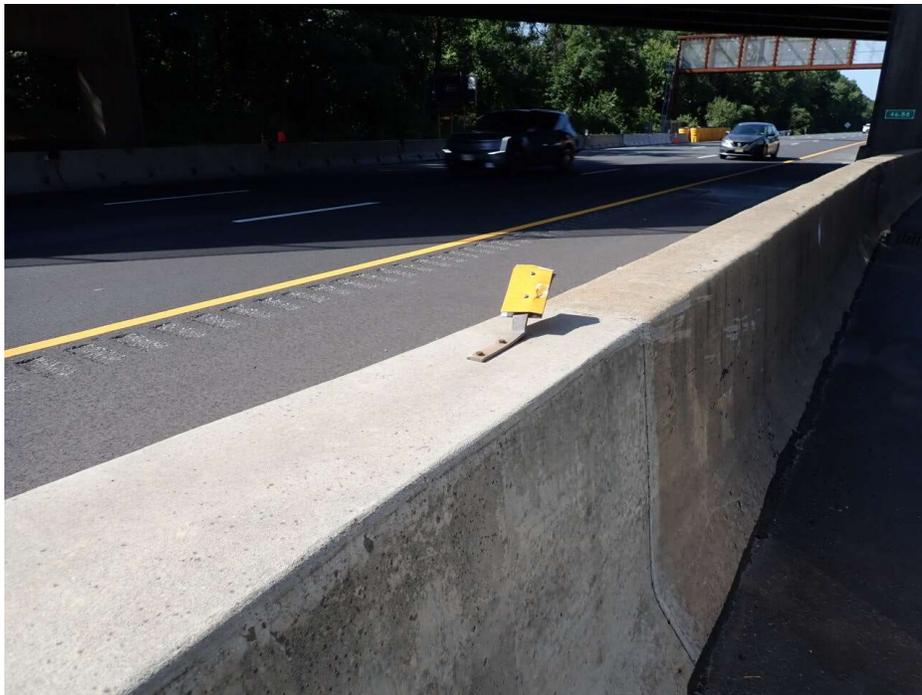
Photograph No. 10

There is one damaged delineator on the median barrier 31' south of the sign structure, looking southeast.
