**NEW JERSEY TURNPIKE AUTHORITY
GARDEN STATE PARKWAY
NEW JERSEY TURNPIKE**

**BRIDGE INSPECTION
PROGRAM**

**MANUAL FOR
RETAINING WALL
AND NOISE BARRIER
INSPECTION**

**VERSION 2.0
JULY 2023**

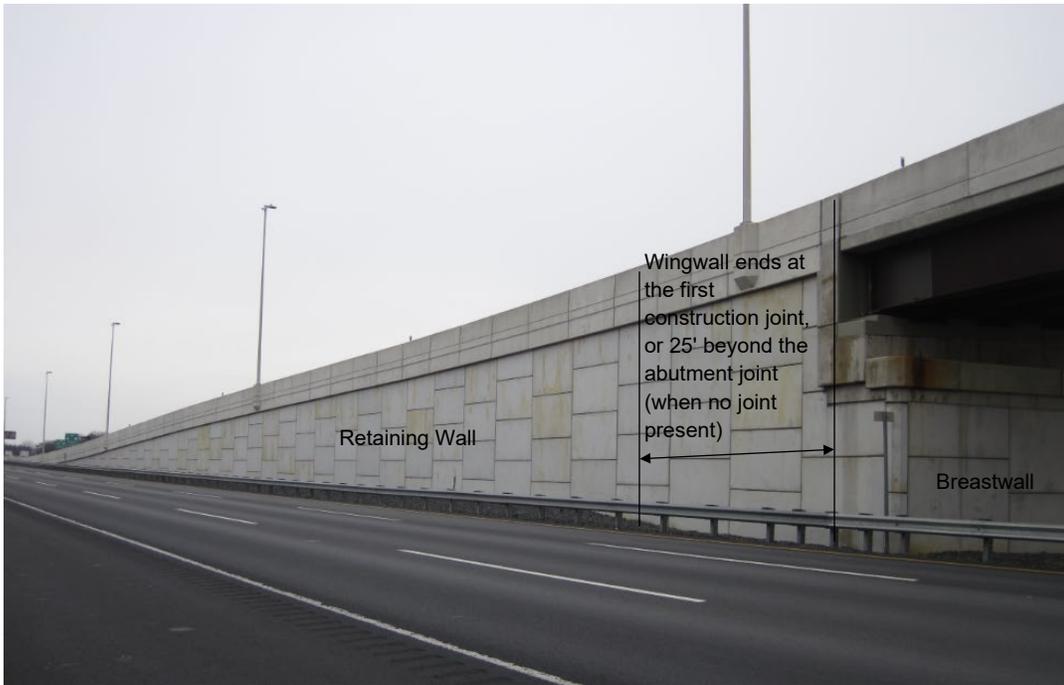
A segmental block mechanically stabilized earth wall is a composite structure consisting of alternating layers of compacted backfill and soil reinforcement elements, fixed to a wall facing.

Photo 1 – Mechanically Stabilized Earth (MSE) Wall (Location – Turnpike SA7S Ramp NISA, MP 72.29NW)

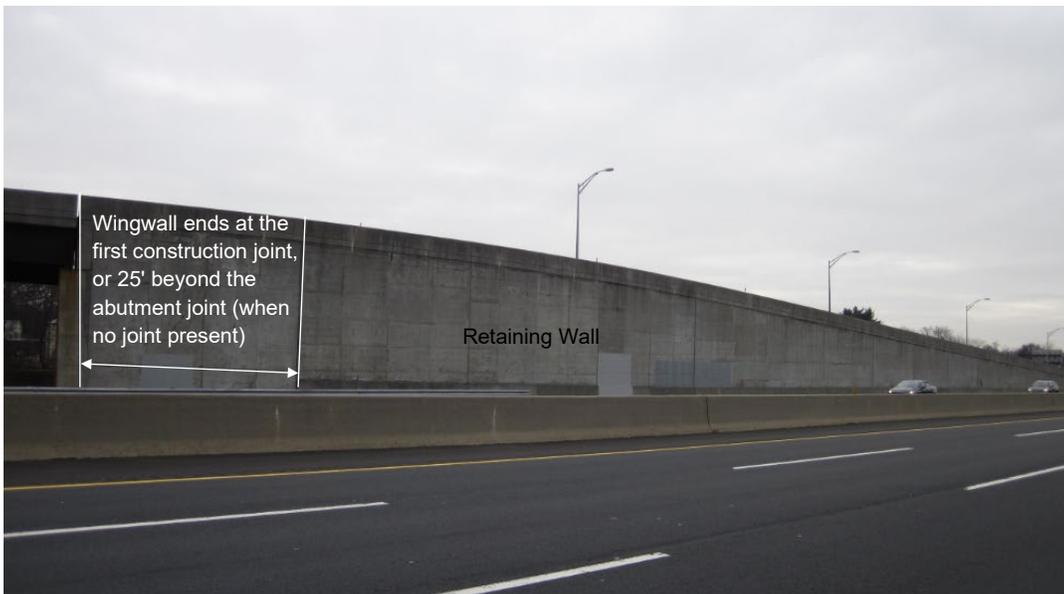
Reinforced Concrete wall is a cast-in-place (or precast) wall comprised of a reinforced concrete vertical stem cantilevered from a base slab.

Photo 2 – Reinforced Concrete Wall (Location – Turnpike SA8N Ramp SISA, MP 78.46SW)

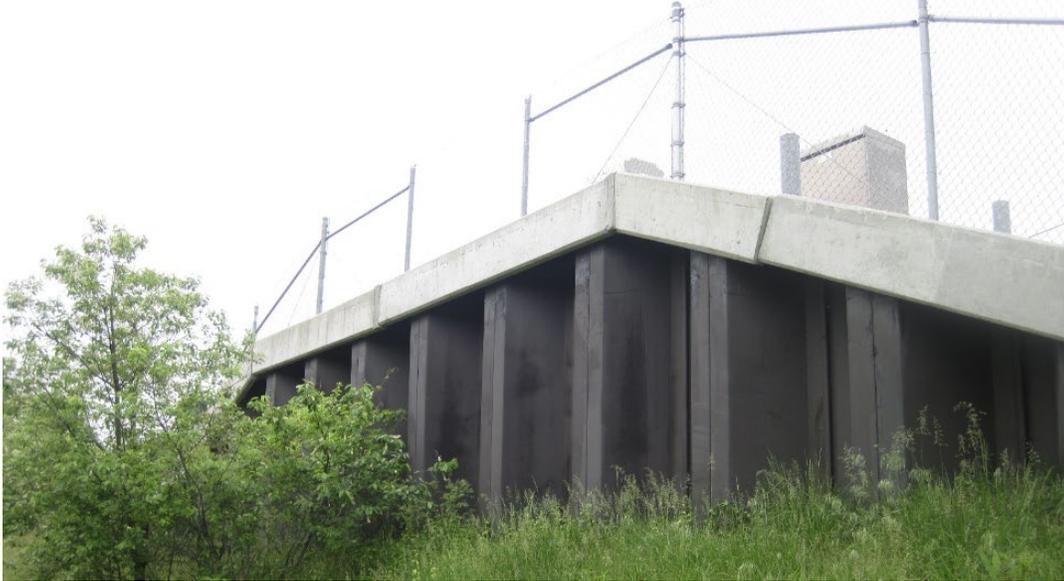
Steel Sheet Piling wall consists of steel sheet piling structural sections with a vertical interlocking system that create a continuous wall. Sheet piles resist soil and water pressures by functioning as a beam spanning vertically between points of support.

Photo 3 – Steel Sheet Piling Wall (Location – Parkway S, MP 31.50S)

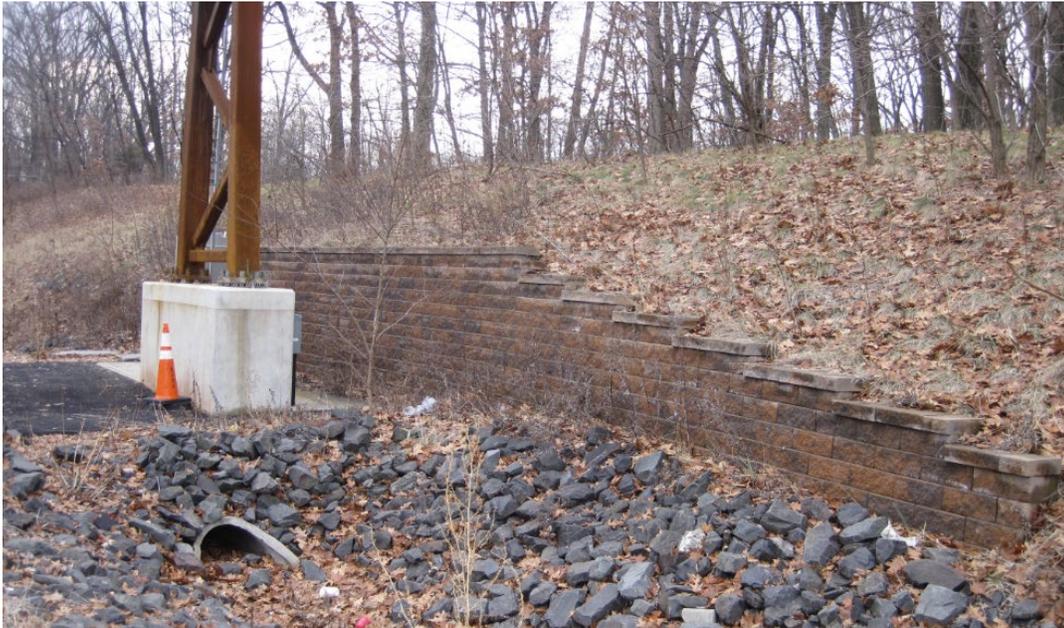
Masonry wall (Block Wall) consists of an assembly of masonry units joined together with mortar or grout.

Photo 4 – Masonry Wall (Block Wall) (Location – Parkway S, MP 131.10S)

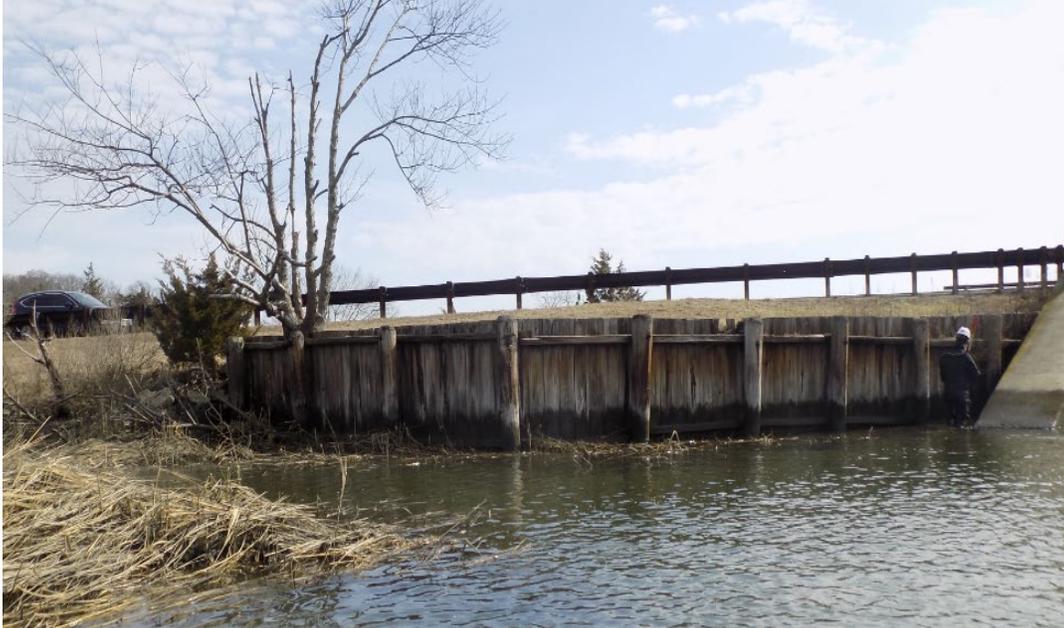
Timber Sheeting wall consists of timber structural sections fastened together with vertical tongue and groove boards, horizontal walers, piles, top cap boards, tie rods, and deadmen.

Photo 5 – Timber Sheeting Wall (Location – Parkway S, MP 2.4S NW)

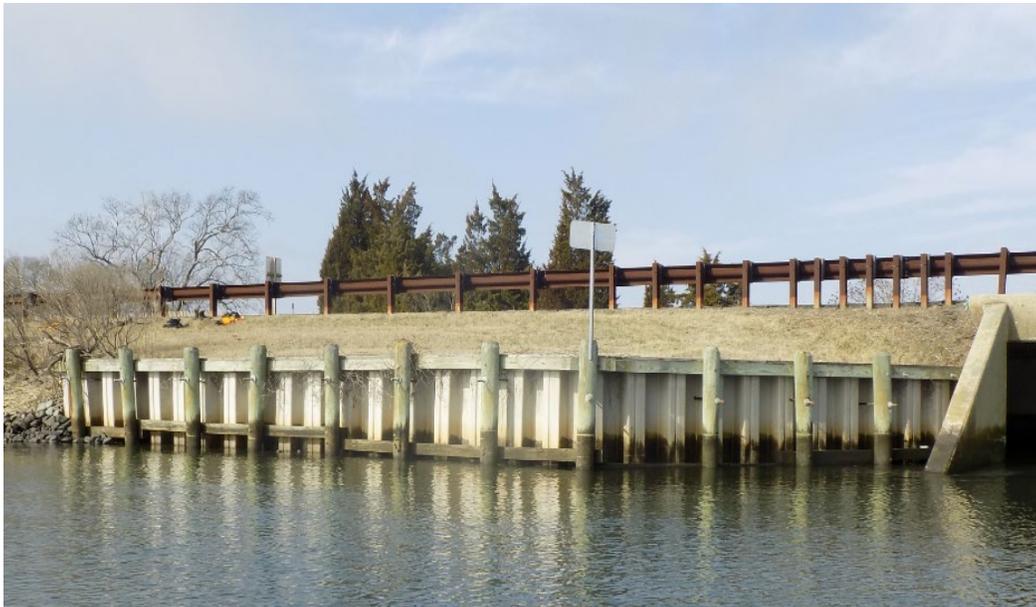
Plastic Sheeting wall consists of plastic sheet piling structural sections fastened together with timber horizontal walers, piles, top cap boards, tie rods, and deadmen.

Photo 6 – Plastic Sheeting Wall (Location – Parkway N, MP 0.5N SE)

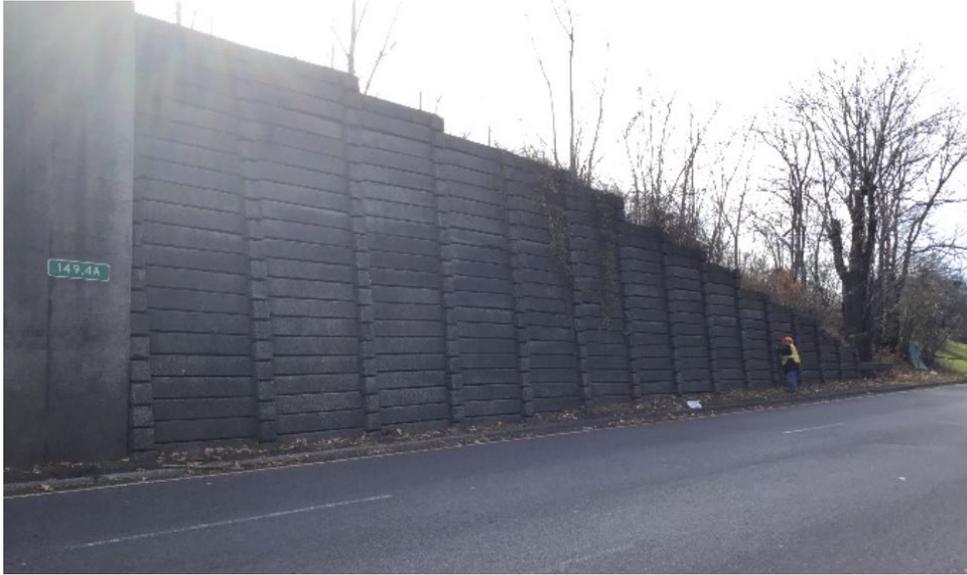
A cribwall is comprised of precast reinforced concrete logs (cribbing) that are assembled like a mini log cabin. Stretchers run parallel with the wall face, while headers run perpendicular to the wall face.

Photo 7 – Cribwall (Location – Parkway S, MP 149.4S)

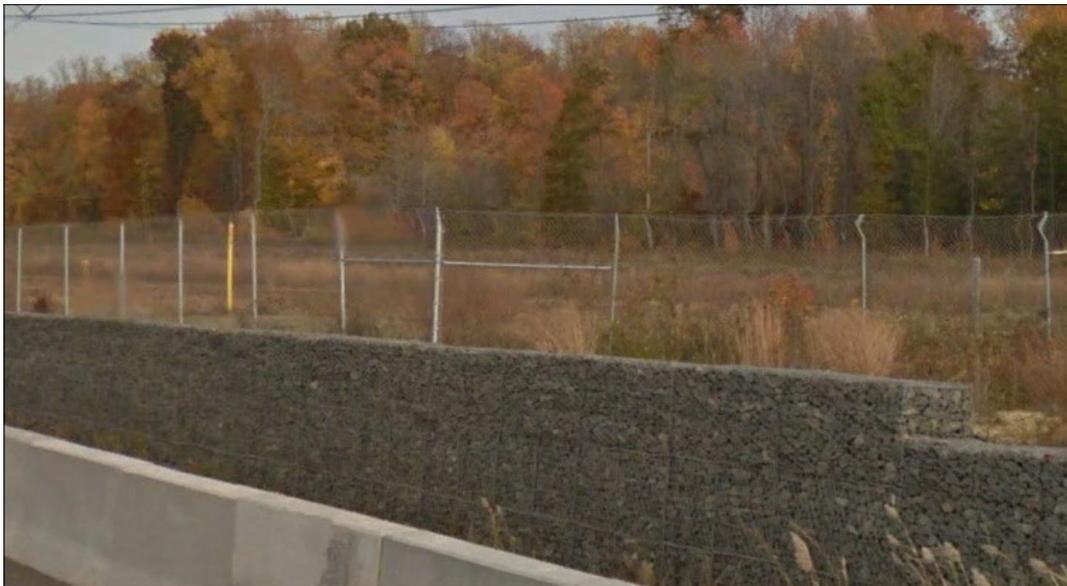
Gabion walls are made up of gabions, or large cages or baskets, which are filled with rocks, gravel, concrete, or leftover construction materials. These large baskets can be stacked together and connected using heavy-duty wire.

Photo 8 – Gabion Wall (Location – Turnpike SNO, MP 52.1NO)

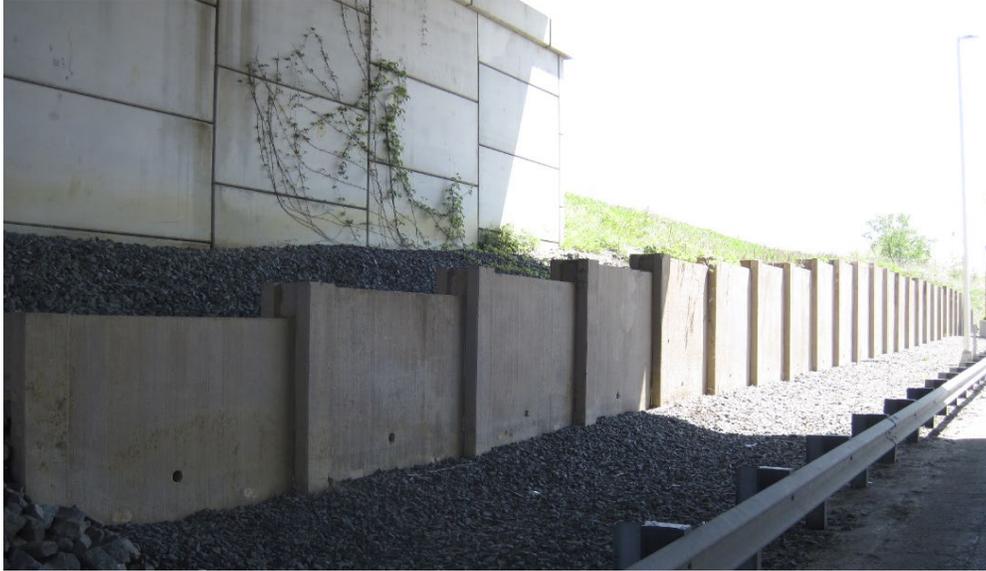
A Post and Panel wall is a structurally engineered, prefabricated/precast reinforced concrete retaining wall system. The system utilizes concrete or steel posts to interlock with the reinforced concrete wall panels.

Photo 9 – Post and Panel Wall (Location – Turnpike Ramp ST, MP 53.75ST)

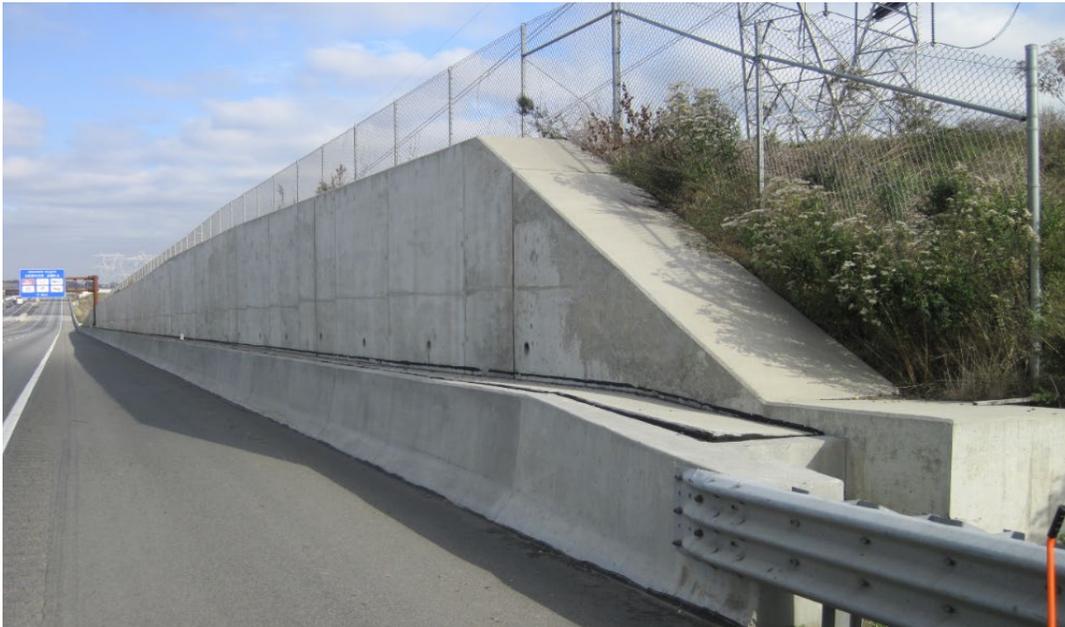
Other/Combination wall includes unique types of retaining wall systems such as steel sheet pile with concrete facing, soldier pile wall, timber lagging and precast lagging panels, and prefabricated modular wall panels with barrier.

Photo 10 – Other/Combination Wall Soldier Pile Wall (Location – Turnpike SNO, MP 56.62NO)

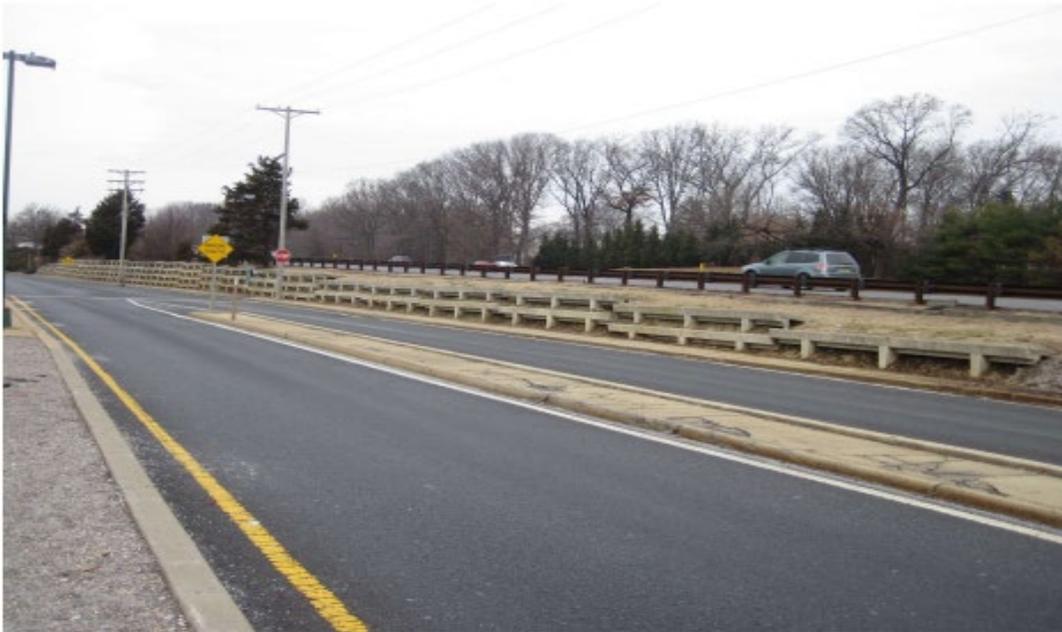
Photo 11 – Other/Combination Wall Evergreen Wall (Location – Parkway NBI, MP 124.10NI)

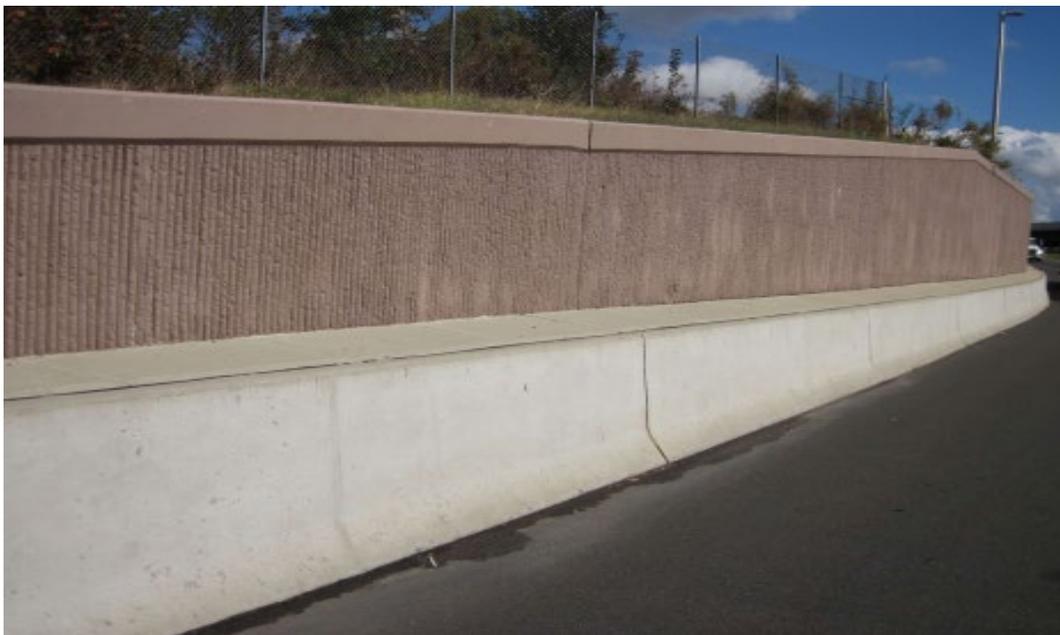
Photo 12 – Other/Combination Wall Steel Sheetting with Concrete Facing Retaining Wall (Location – Turnpike Interchange 7 Ramp NOT, MP 53.85NOT)

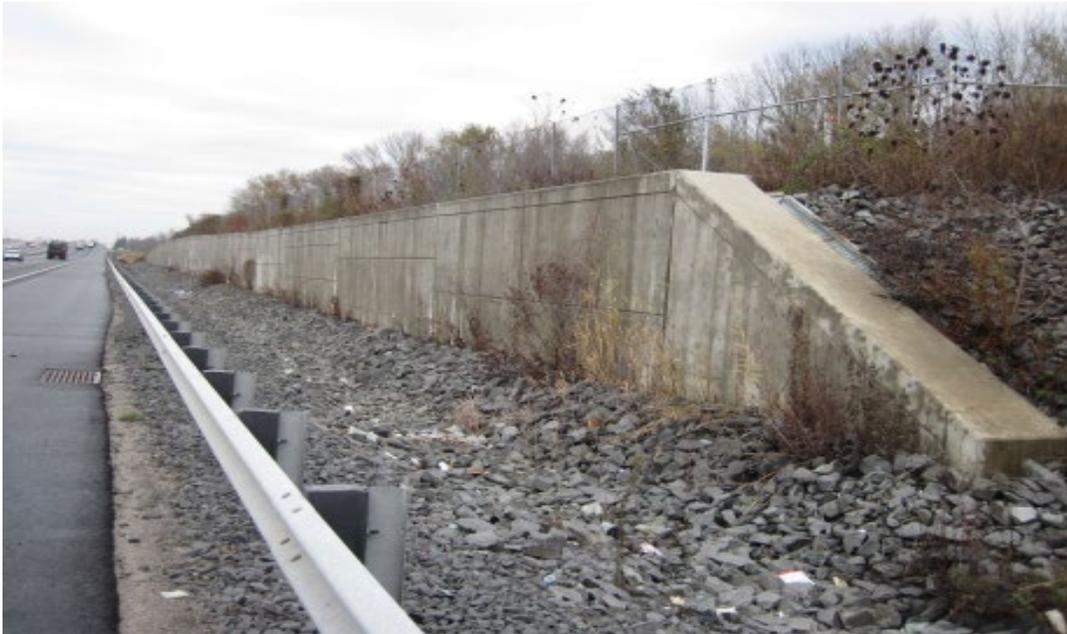
***Photo 13 – Other/Combination Wall Timber Lagging with Concrete Facing Retaining Wall
(Location – Turnpike NSO, MP 69.3NO)***

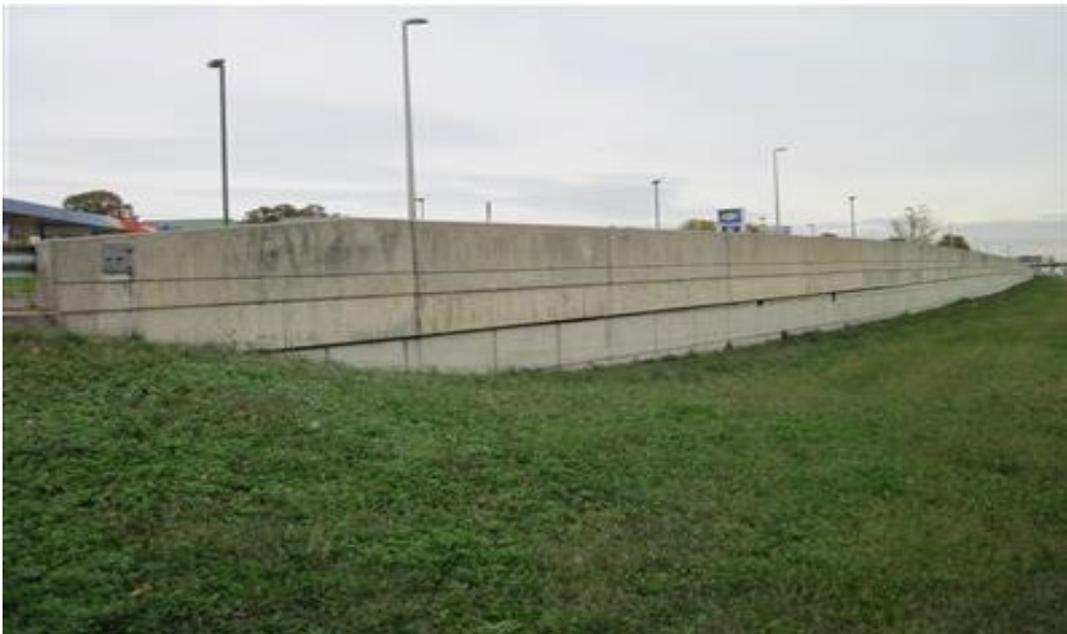
***Photo 14 – Other/Combination Wall Prefabricated Modular Wall Panels with Barrier
(Location – Turnpike SA7S Ramp SAS, MP 71.72SAS)***

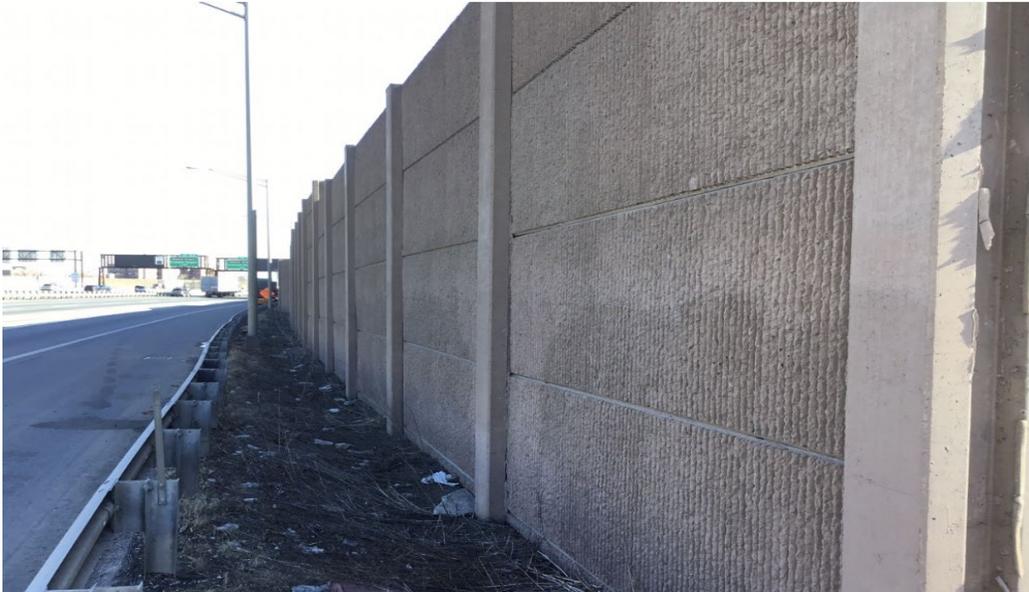
A Post and Panel noise barrier is a structurally engineered, prefabricated system which consists of separate reinforced concrete panels placed between supporting columns or steel posts.

Photo 15 – Post and Panel Noise Barrier (Location – Turnpike SNO, MP 99.87NO)

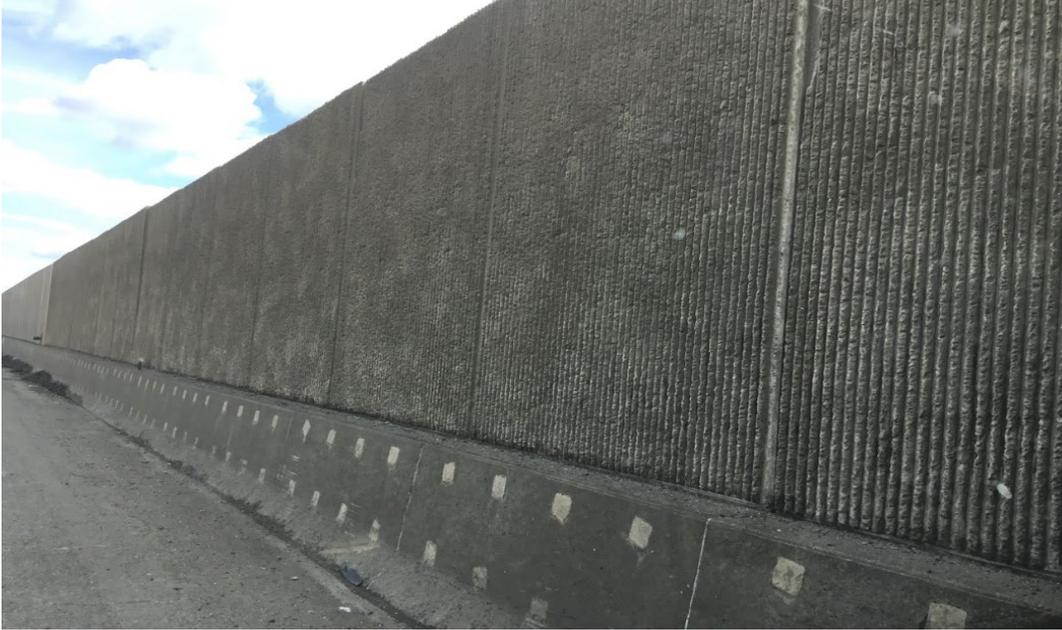
Reinforced Concrete noise barrier is a cast-in-place (or precast) noise barrier comprised of a reinforced concrete vertical stem cantilevered from a base slab.

Photo 16 – Reinforced Concrete Noise Barrier (Location – Turnpike SNO, MP 100.45NO NE)

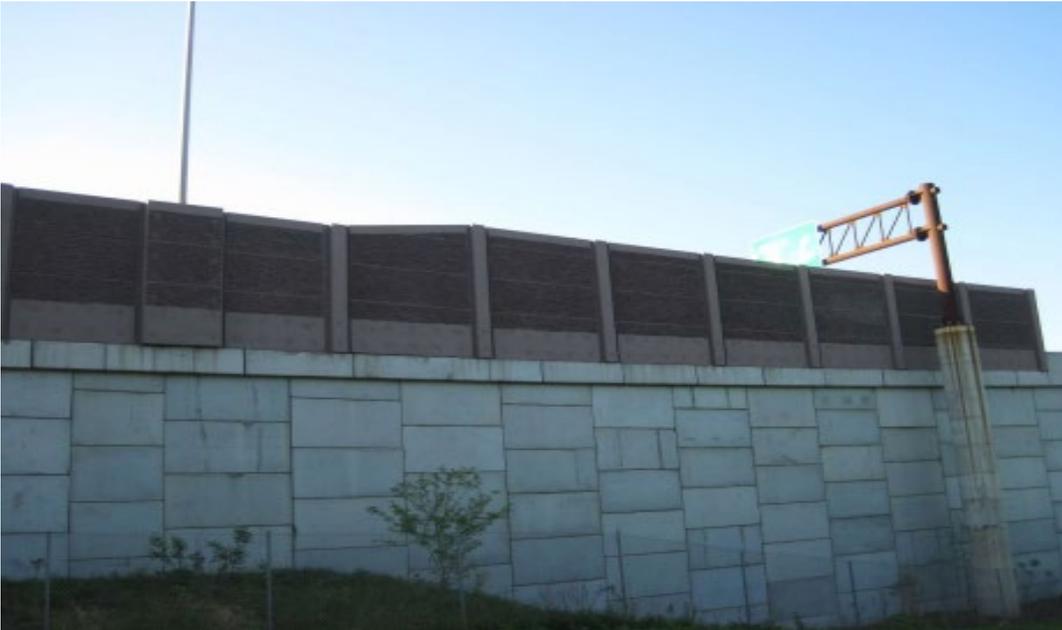
Other/Combination noise barrier types include wall systems utilized together (i.e. noise barrier constructed on top of a retaining wall).

Photo 17 – Other/Combination Noise Barrier Post and Panel Noise Barrier on Top of the MSE Wall (Location – Turnpike NSO, MP 54.00SO SW)

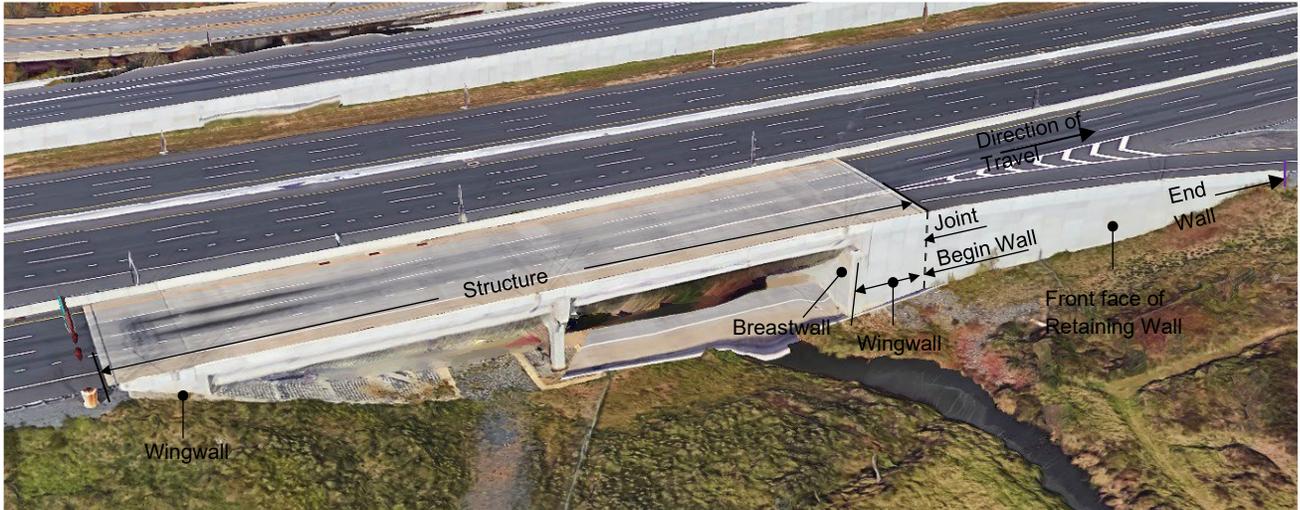
1. When the retaining wall extends from the bridge substructure and the joint between the retaining wall and the bridge wingwall is visible, the limits of the retaining wall (Begin MP) shall be considered to start at that visible joint. The total length of the retaining wall shall be measured from the joint to the end of the wall [See Figure 1].

Figure 1-Begin and End of Retaining Wall (Visible Joint)

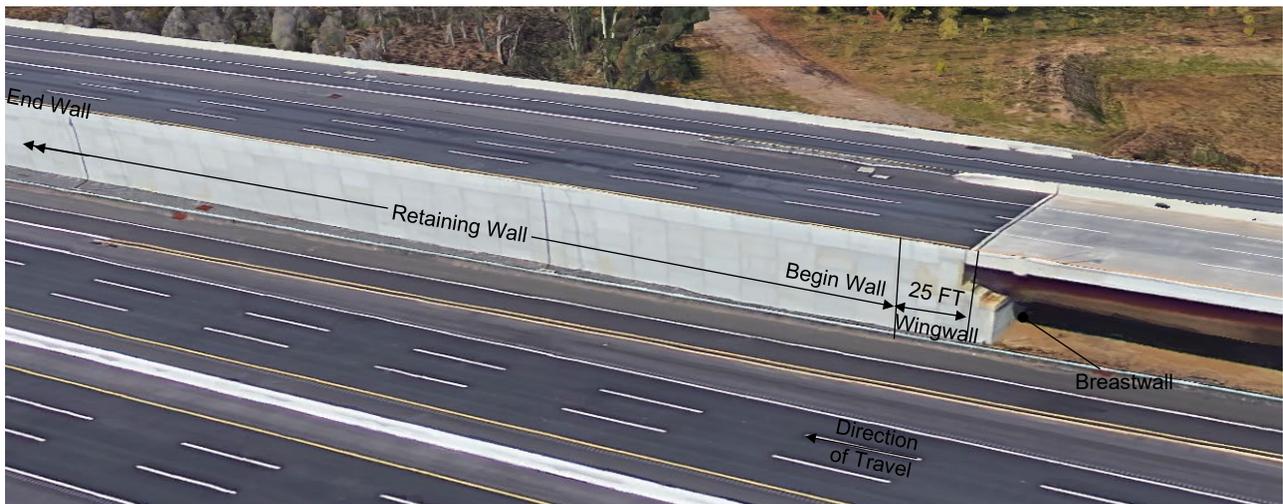
2. When the retaining wall extends from the bridge substructure and the joint between the retaining wall and the bridge wingwall is not visible, the retaining wall (Begin MP) shall be considered to start 25 feet from the abutment joint. The total length of the retaining wall is measured from the established beginning of the wall to the end of the wall. The initial 25 feet of the wall (considered as the wingwall) is included in the associated bridge or culvert inspection and should not be inventoried or inspected as a retaining wall. [See Figure 2].

Figure 2-Begin and End of Retaining Wall (No Visible Joint)

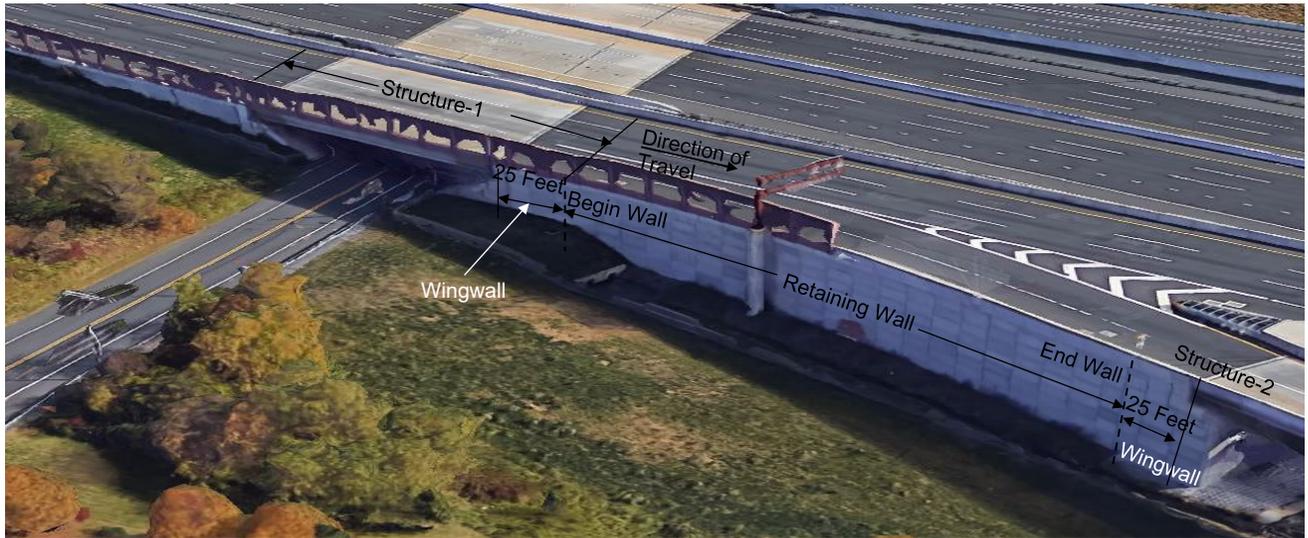
3. When a retaining wall exists between two structures with no visible joints between the wingwalls and retaining wall, the retaining wall (Begin MP) shall start 25 feet from the abutment joint of Structure No. 1 and shall end (End MP) 25 feet from the abutment joint of Structure No. 2. [See Figure 3]

Figure 3-Begin and End of Retaining Wall Between Two Structures

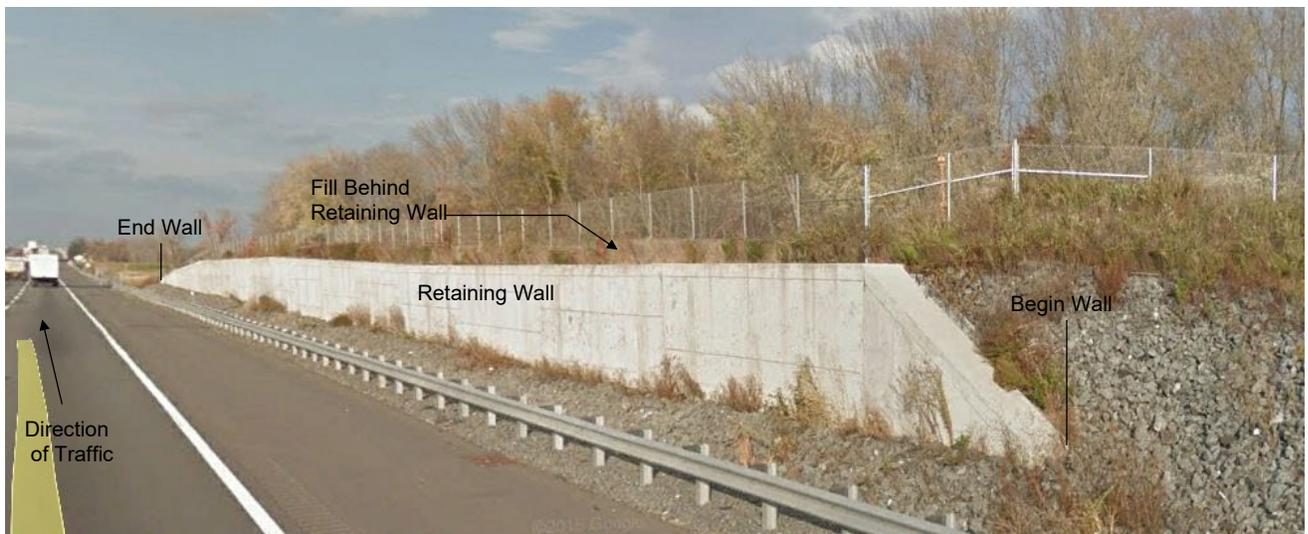
4. When a standalone retaining wall is located along the Turnpike and Parkway roadways, the beginning of the retaining wall (Begin MP) shall be the first point encountered while traveling in the direction of traffic and the end of the wall shall be at the termination of the wall. [See Figure 4]

Figure 4-Standalone Retaining Wall (along Mainline shown)

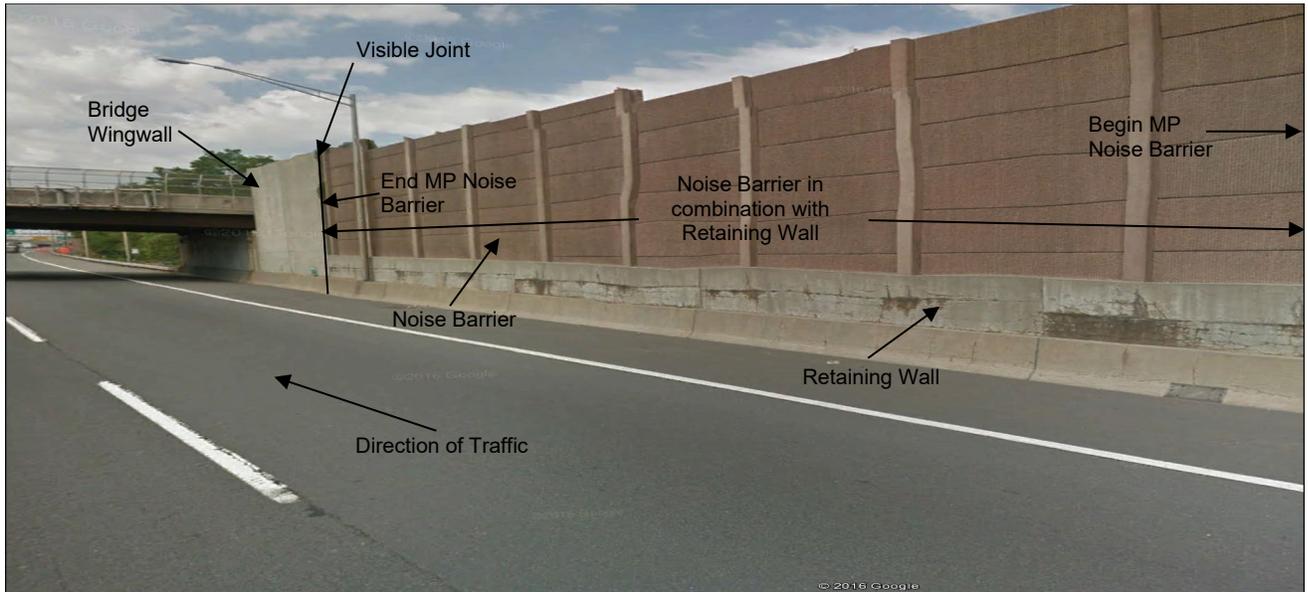
5. When a noise barrier and retaining wall are present, the retaining wall and noise barrier shall be inventoried and inspected as one combined structure and shall be designated a noise barrier. The beginning of a noise barrier is the first point encountered while travelling in the direction of traffic and the end of the noise barrier is at the termination of the noise barrier. **[See Figure 5]**

Figure 5-Combination of Noise Barrier and Retaining Wall

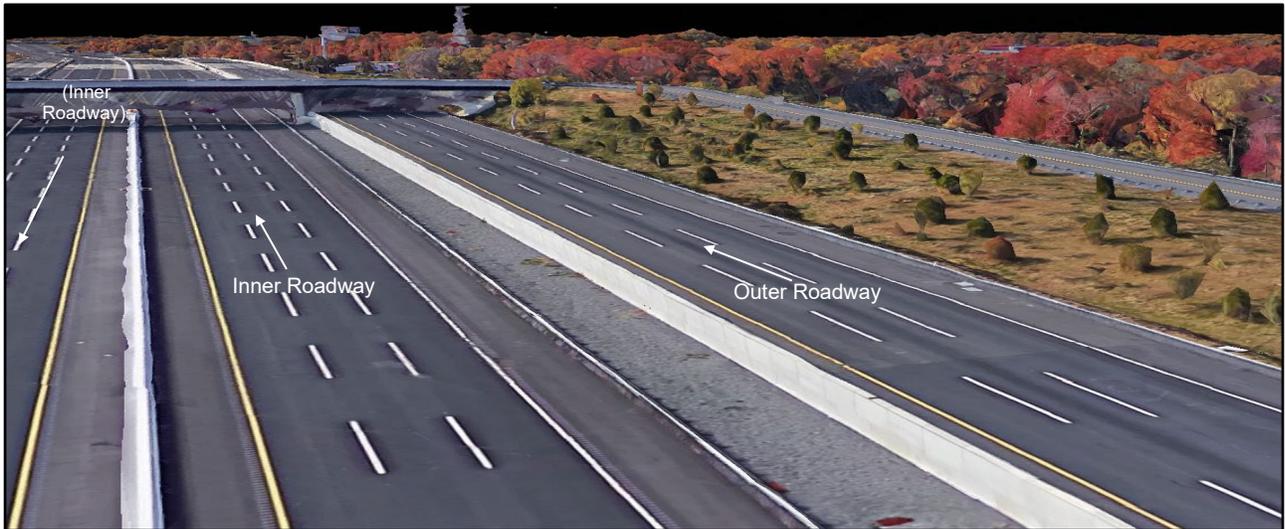
Figure 6- Median Barrier Between Outer and Inner Roadways

- Wingwall extending 25 feet from a bridge abutment shall be inspected with the bridge and therefore is considered a non-qualified retaining wall.
- Median barriers between adjacent roadways and walls or barriers in front of bridge abutments acting to retain soil shall be considered non-qualified retaining walls, shall be inspected with the bridge, and are considered non-qualified retaining walls. **[See Figure 6 and Figure 7]**
- Noise barriers on top of a wingwall that are located within 25 feet from bridge abutment joints shall be inspected with the bridge and are considered non-qualified noise barriers. **[See Figure 8]**

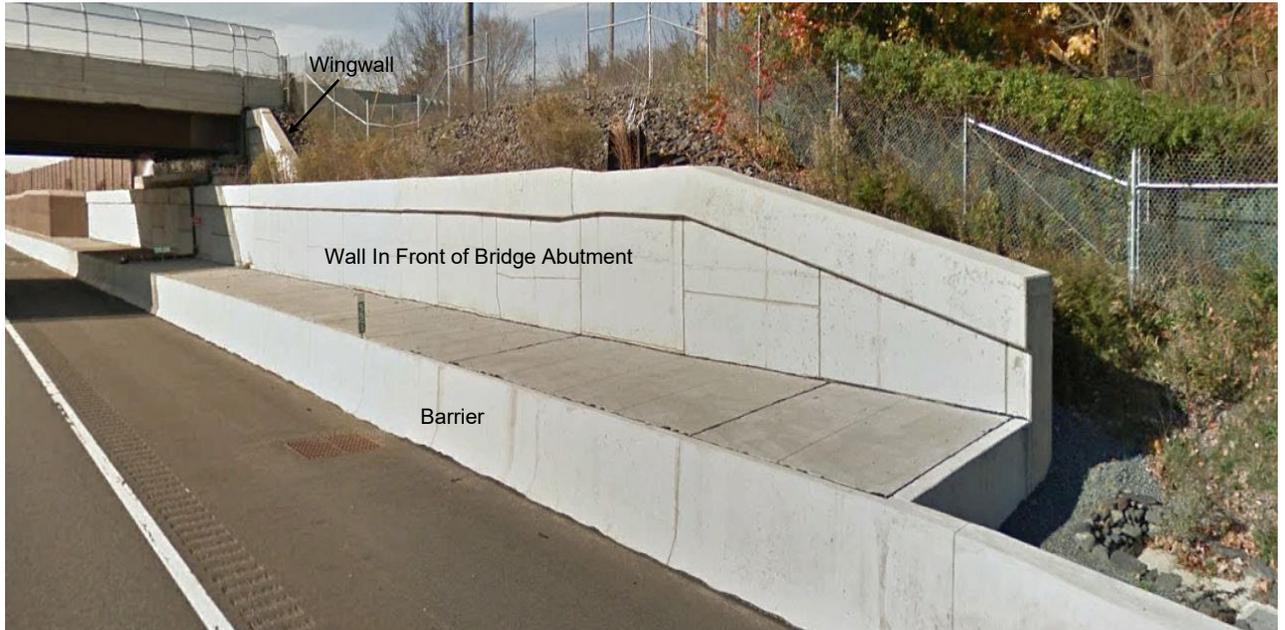
Figure 7- Wall in Front of Abutment

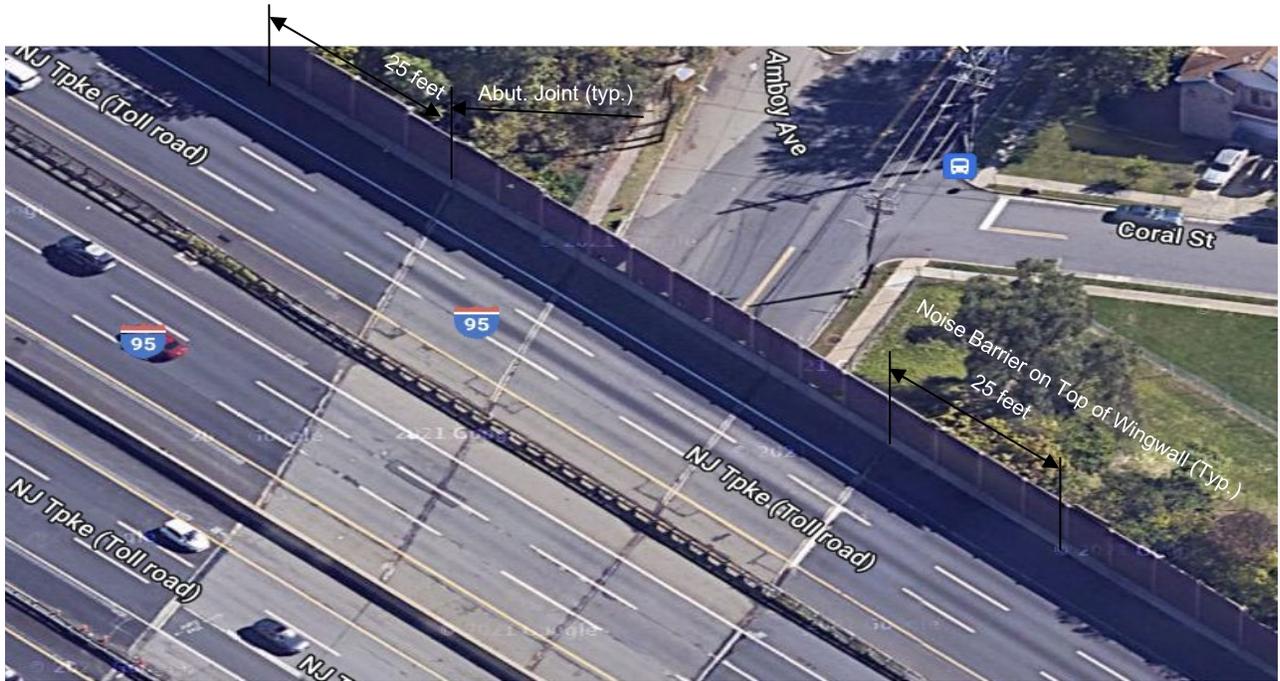
Figure 8- Noise Barrier on Top of Wingwall and Structure

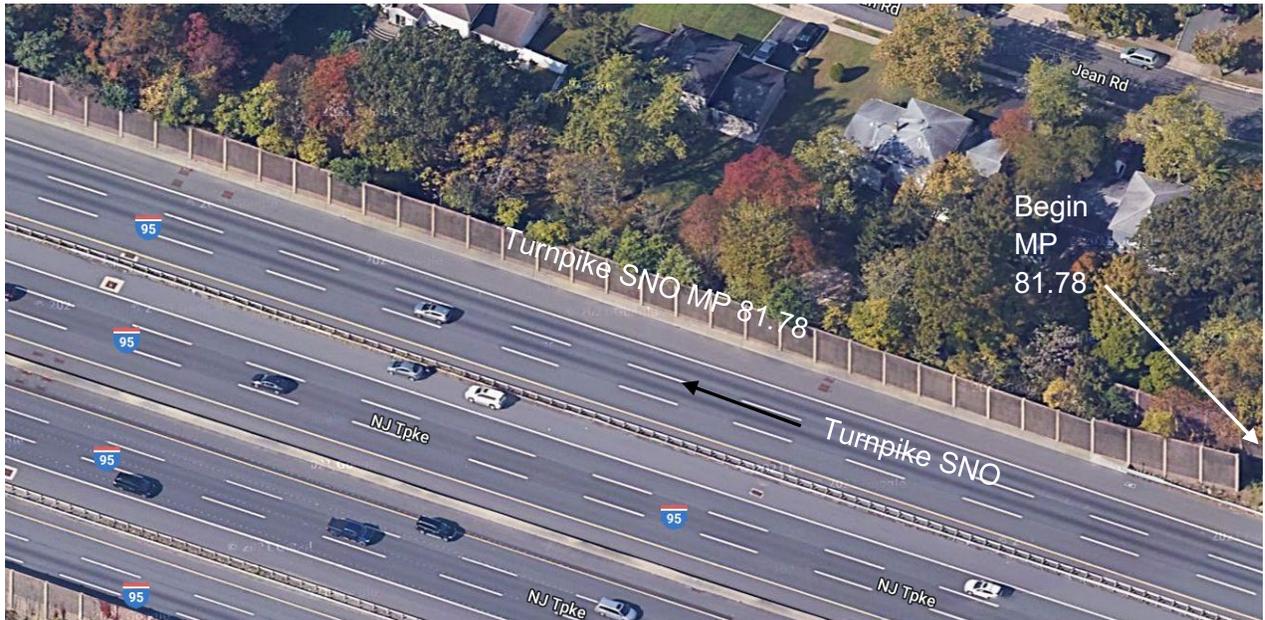
1. The Structure Number (Asset Name) for a standalone noise barrier located along the Turnpike SNO Roadway at Begin MP 81.78 is MP 81.78NO. The corresponding Structure Name (Asset Code) for the noise barrier is Turnpike SNO MP 81.78. **[See Figure 9]**

Figure 9 – Noise Barrier Along Turnpike Mainline

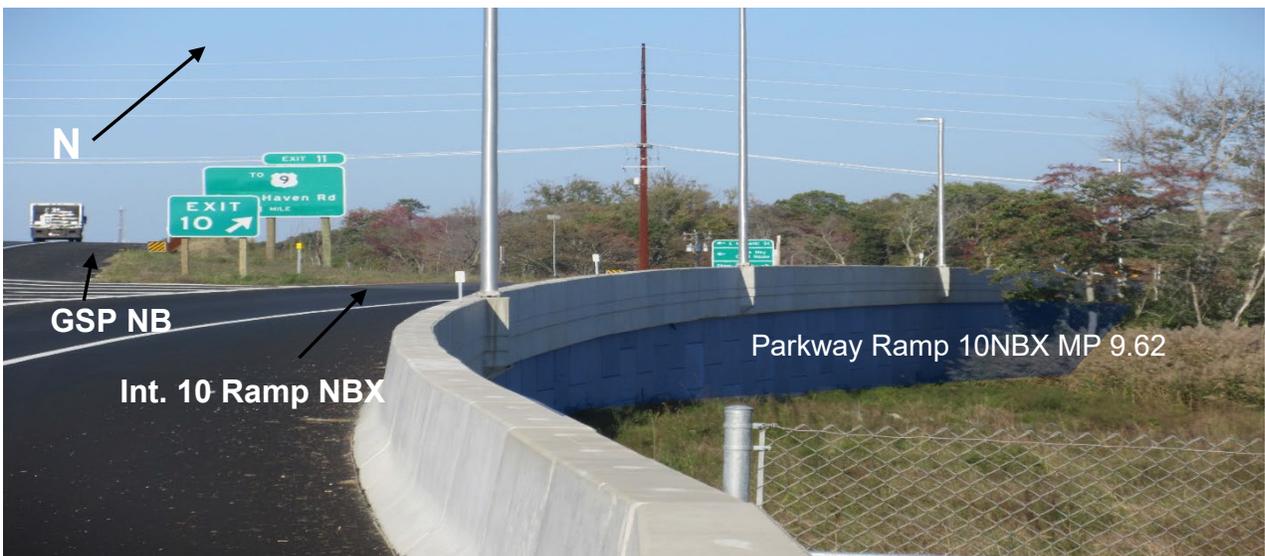
2. The Structure Number (Asset Name) for a retaining wall or noise barrier on Ramp NBX at Interchange 10 with Begin MP of 9.62 is MP 9.62NBX. The corresponding Structure Name (Asset Code) for the retaining wall is Parkway Ramp 10NBX MP 9.62. **[See Figure 10]**

Figure 10 – Retaining Wall or Noise Barrier at Parkway Ramp

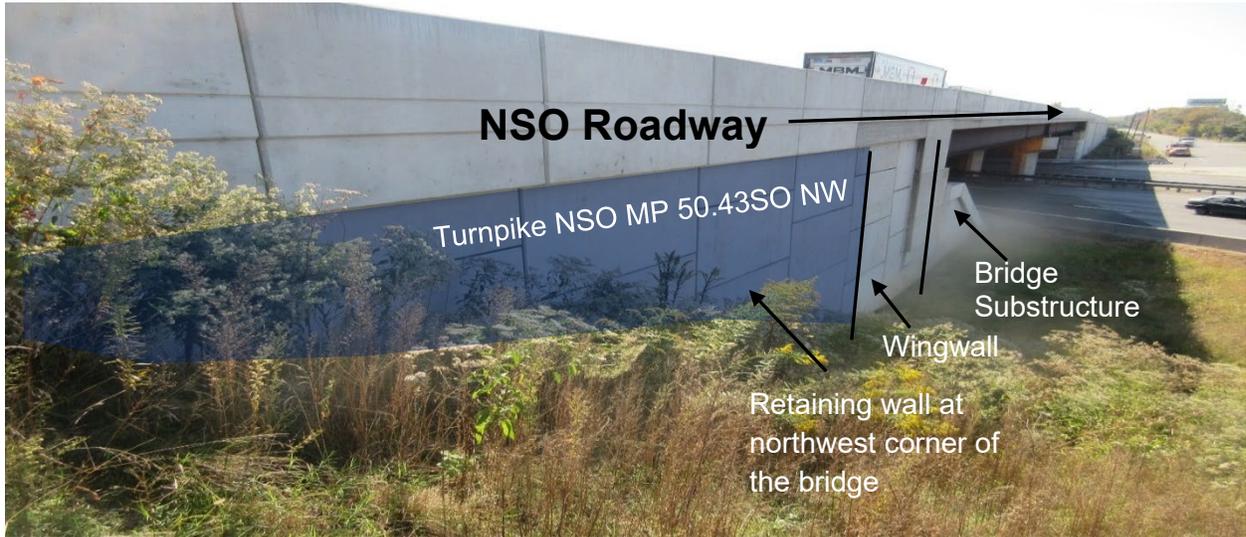
3. The Structure Number (Asset Name) for a retaining wall extending from a bridge located along the Turnpike Mainline Roadway at Bridge No. 50.43SO and supporting the NSO Roadway at the northwest corner is MP 50.43SO NW. The corresponding Structure Name (Asset Code) for this retaining wall is Turnpike NSO MP 50.43SO NW. The retaining wall supports the fill for the Turnpike roadway. **[See Figure 11]**

Figure 11 – Retaining Wall at Extension of Mainline Bridge (Turnpike Shown)

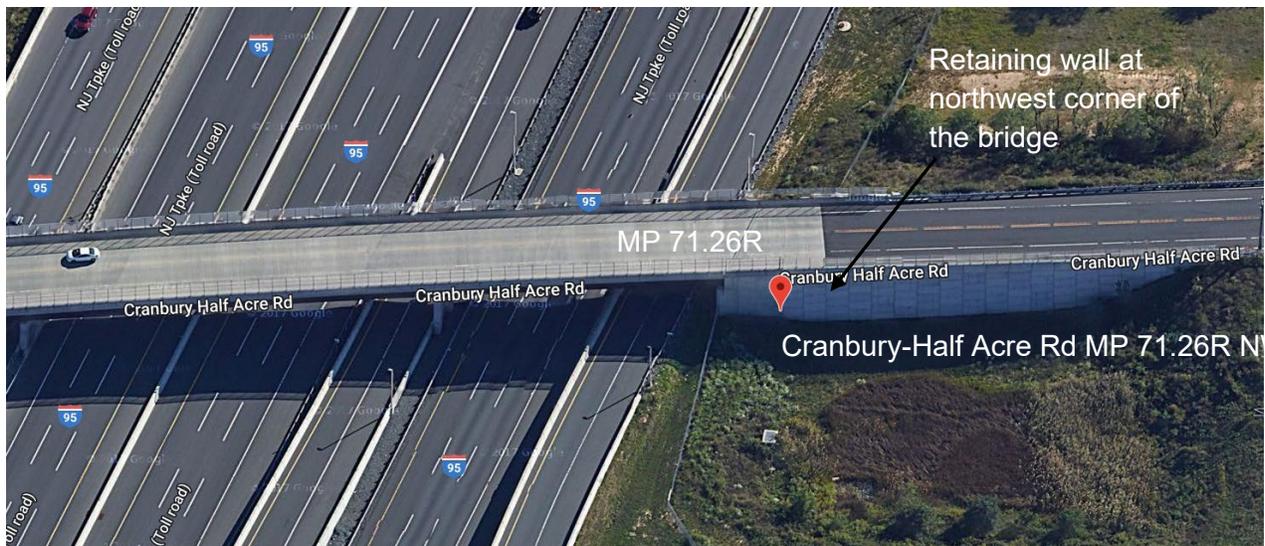
4. The Structure Number (Asset Name) for a retaining wall or noise barrier extending from local road over bridge MP 71.26R, Cranbury-Half Acre Road at the northwest corner is MP 71.26R NW. The corresponding Structure Name (Asset Code) for the retaining wall is Cranbury-Half Acre Road MP 71.26R NW. **[See Figure 12]**

Figure 12 – Retaining Wall at Extension of Local Road Over Bridge
