**NEW JERSEY TURNPIKE AUTHORITY
GARDEN STATE PARKWAY
NEW JERSEY TURNPIKE**

**BRIDGE INSPECTION
PROGRAM**

**MANUAL FOR
RETAINING WALL
AND NOISE BARRIER
INSPECTION**

**VERSION 2.0
JULY 2023**

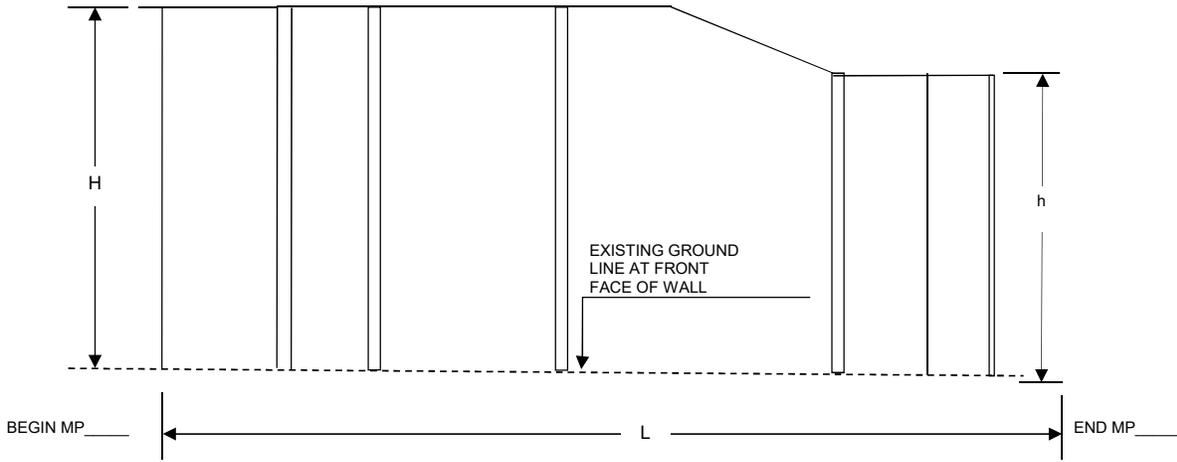
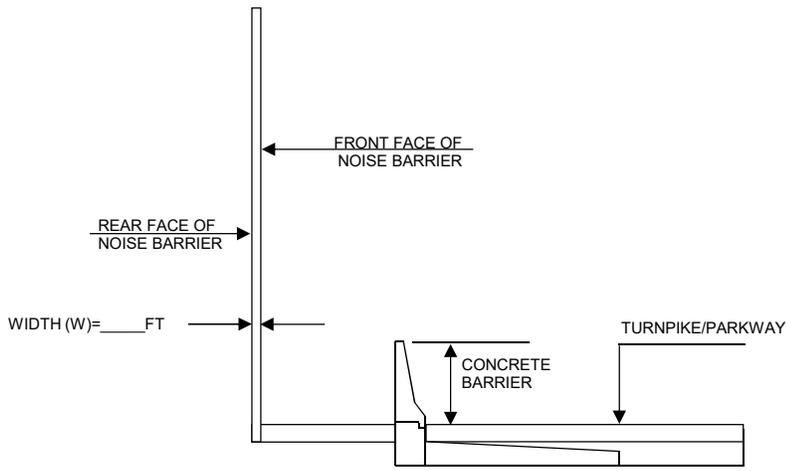
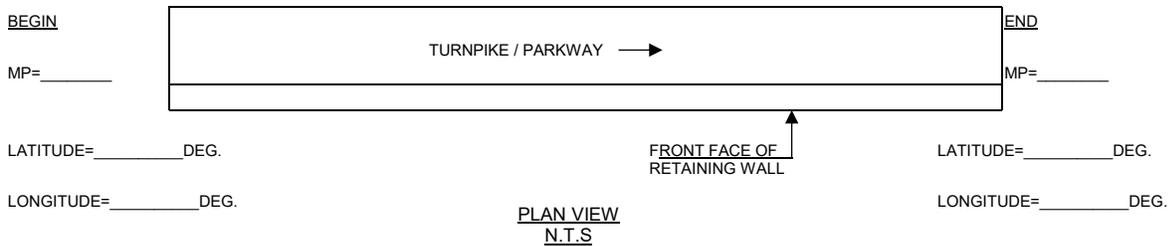
FIGURE 14-NOISE BARRIER AT TURNPIKE AND PARKWAY MAINLINE

FRONT FACE OF NOISE BARRIER (ELEVATION)
 N.T.S.

TYPICAL CROSS SECTION
 N.T.S.

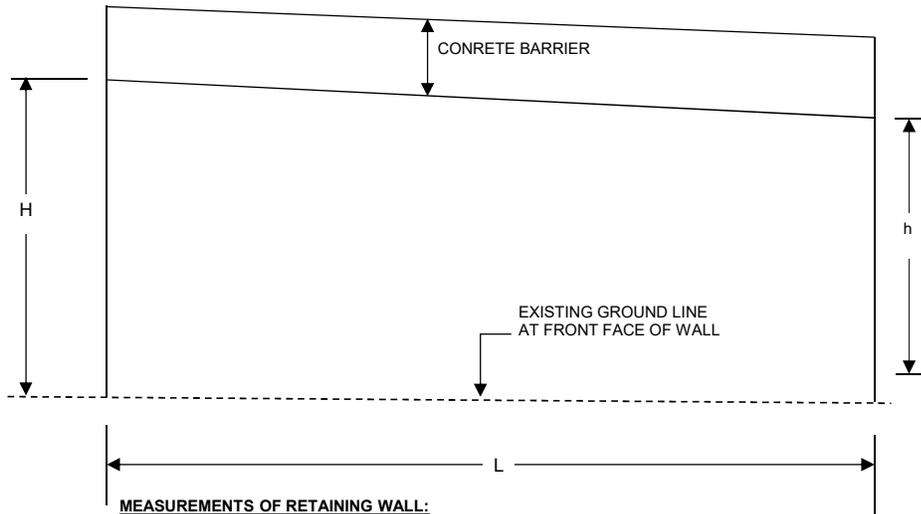
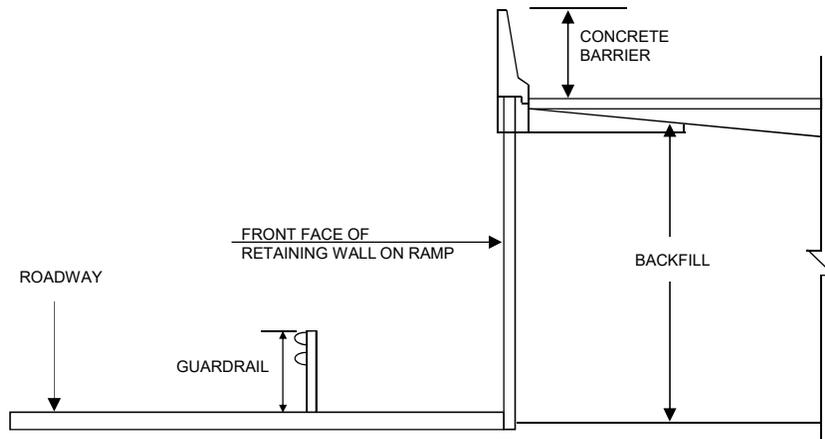
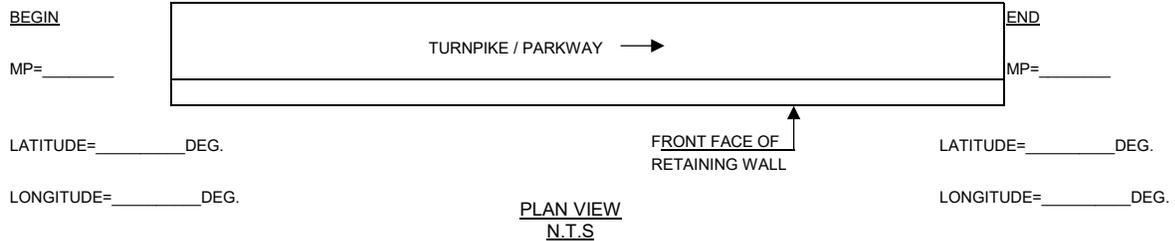
FIGURE 15-RETAINING WALL AT TURNPIKE AND PARKWAY RAMP

FRONT FACE OF RETAINING WALL
(ELEVATION)
N.T.S.

TYPICAL CROSS SECTION
N.T.S.

PLAN VIEW
N.T.S.
